# **1993 RIPARIAN MANAGEMENT ZONE SURVEY**

**TFW Field Implementation Committee**

June 20, 1994

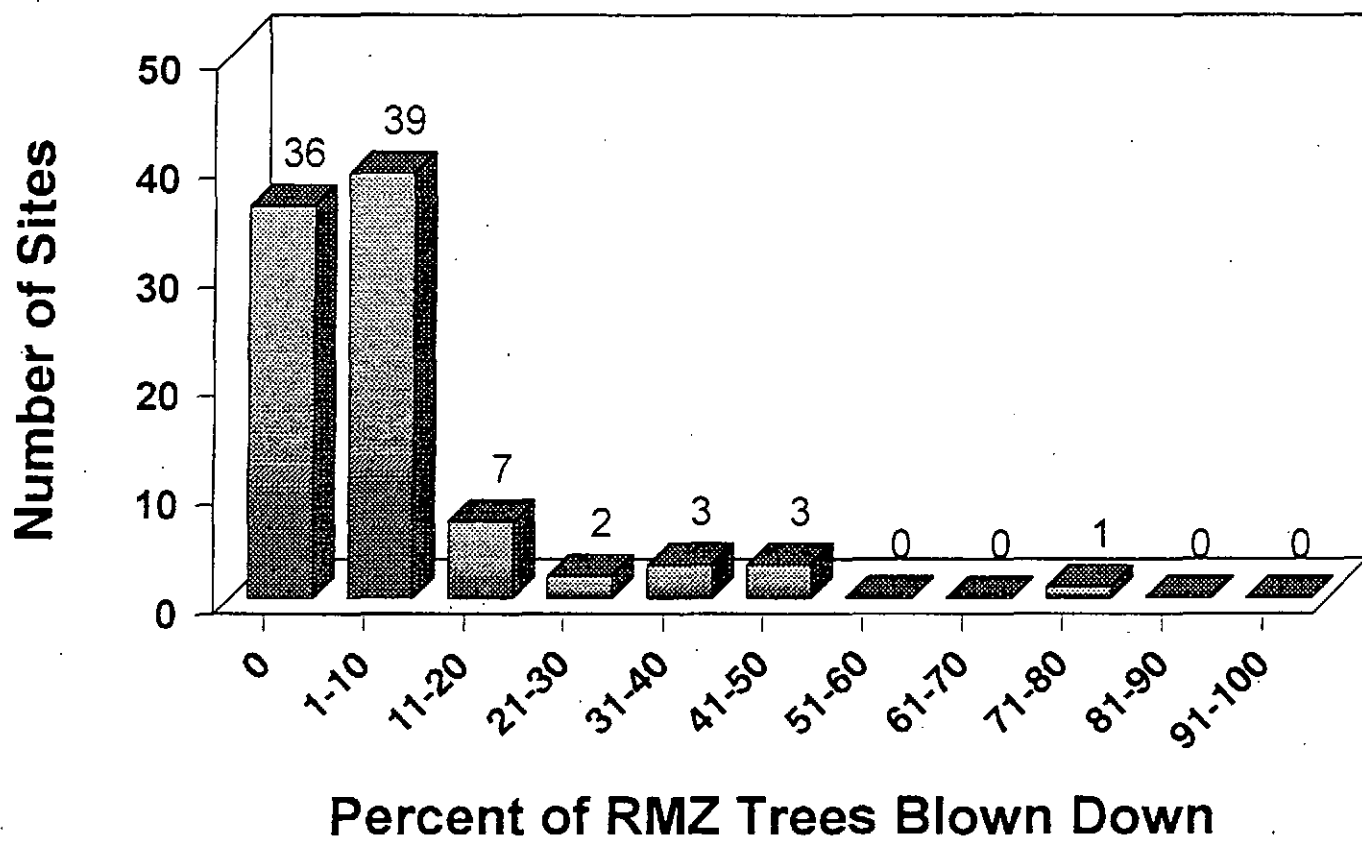
# RMZ Blowdown Survey Results

The results of the blowdown survey are shown in Figure 1. In summary, 82% of the RMZs surveyed had 10% or less of the leave trees blown down. Only one site had more than 50% blowdown. Three of the 94 samples were not used in this blowdown summary. Two samples were recently harvested and did not meet time requirements necessary to qualify for inclusion. One sample had no information.
