**A ROAD DAMAGE INVENTORY  
FOR  
THE UPPER DESCHUTES RIVER BASIN**

By  
Steven Toth

JANUARY 1991

A Final Report  
Submitted to the SHAMW Committee.  
by  
Steven Toth  
January, 1991

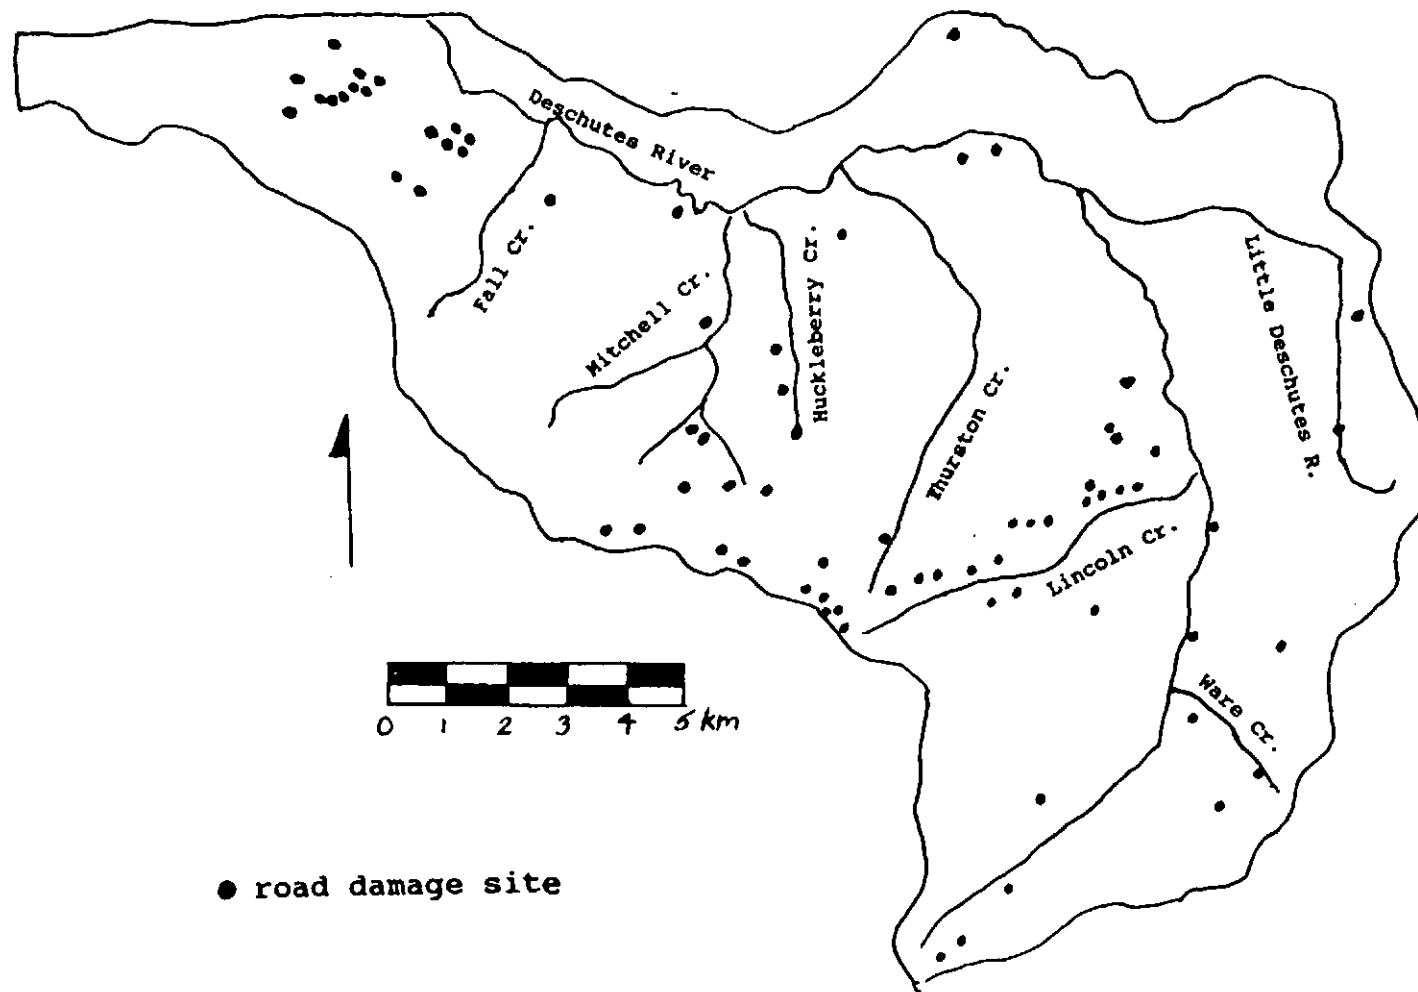
Figure 4. Location of Sample Road Damage Sites

A total of 76 road damage sites were evaluated for this study (see figure 4). The sites were chosen by the Vail Tree Farm road engineer. Since there were hundreds of sites that incurred varying degrees of damage, a sample of them needed to be taken. The sites, however, were not catalogued in any way, and therefore were simply chosen from memory by the engineer. Statistical analysis of the data was not possible because this was not a random and non-biased sample, but the information could still provide insight into the various types of problems in the watershed. The engineers felt it was a proportionately representative sample including most of the larger and more obvious problems that caused serious damage, as well as the smaller and less serious damage sites. Many of the sites had been repaired by the time of this study, making it difficult at times to accurately assess the causes for failure. The engineers, though, were able to provide the necessary information to evaluate the site conditions prior to repair work.

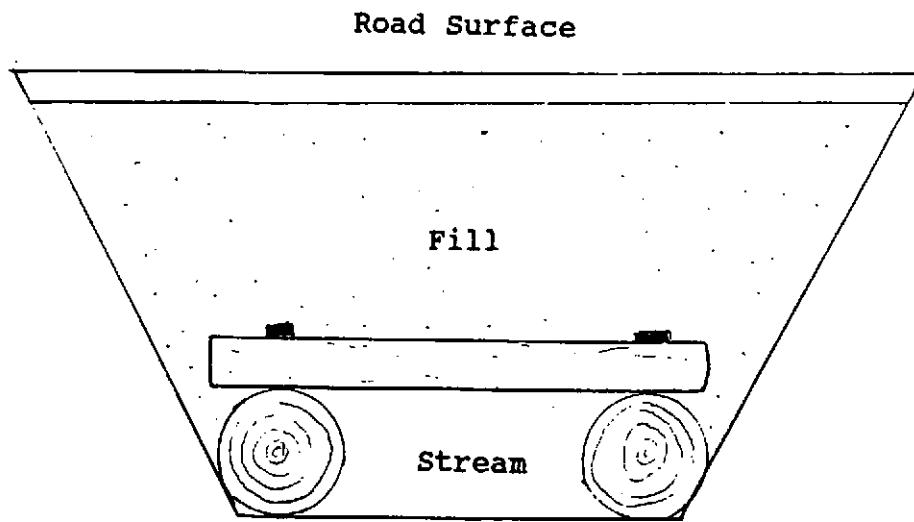
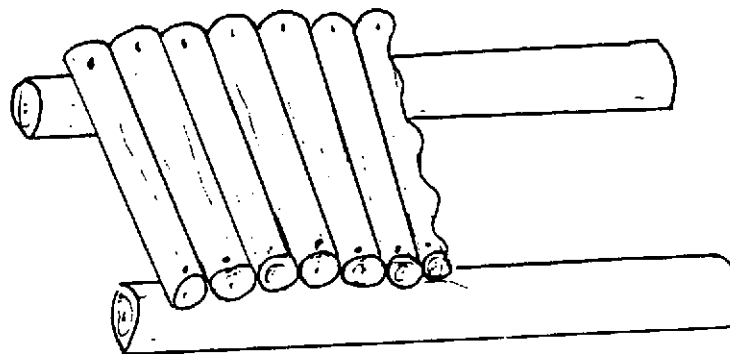
Figure 8. Cedar Punccheon Culvert

Culverts were the next most significant problem accounting for 29% of the damage sites. Stream culverts represented 22% and relief culverts 7% of the sites. Nearly half of the stream culvert problems involved cedar puncheon culverts, all of which caused some environmental damage. Eighty-one percent of the stream culvert problems caused significant environmental damage. The major cause of culvert problems was blockage of culverts (68% of the cases).

Culvert size is an important consideration presently because many of the older culverts need replacing. The cedar puncheon culverts were predicted to last 25-30 years (Silversides, 1949) and their replacement with steel culverts is long overdue. Many of these culverts have been replaced, but many remain in place. Considering the potential for environmental damage when they fail, replacing cedar culverts should be the top priority.

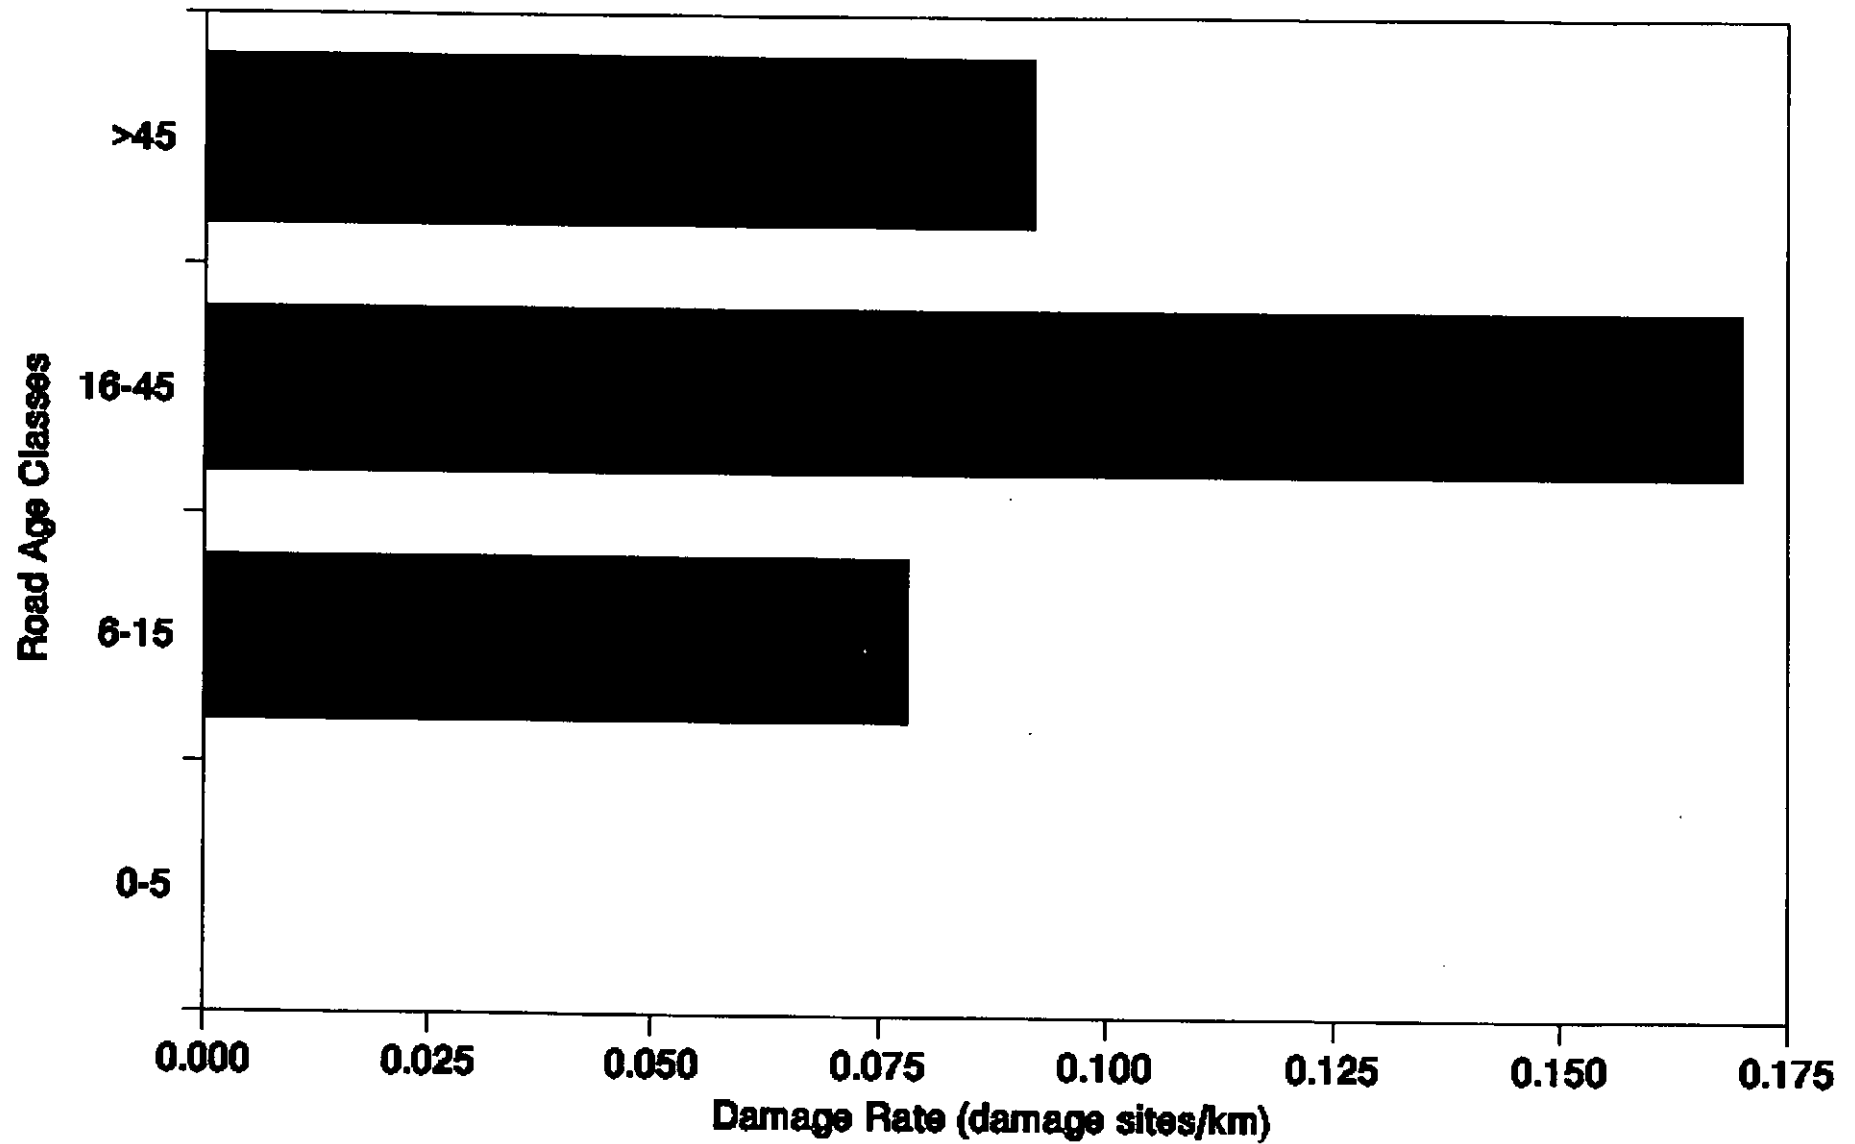
**Figure 9. Damage Rate by Road Age Class**

Combining the information from the age class map and road damage form showed significant differences in the damage rate between road age classes (see figure 9 and table 1). There was no damage to roads built in the last five years. Roads built from 6-15 years ago averaged .078 damage sites/km. Roads built from 16-45 years ago averaged .170 damage sites/km. Railroad grade roads averaged .092 damage sites/km. All of the damage on railroad-grade roads occurred in partially-reconstructed sections.

There are many reasons for the ability of the newer roads to withstand a storm that far exceeded design standards. First, culverts are designed to withstand at least a 50-year flood event, and often times, the present engineers will exceed the size recommendation given by the United States Geological Survey (U.S.G.S.) culvert sizing equation (Cummins et al., 1975) to increase their margin of safety. Perhaps the most important change

The oldest age class of roads and those built 6-15 years ago only averaged a damage site every 10.9 km and 12.8 km respectively. The durability of the youngest roads can be better tested in the future as more roads are built, and as they weather the elements longer.

The roads built from 6-15 years ago fared better overall than the older roads with about half the damage rate of the 16-45 year age class of roads. The most notable difference between these age classes, though, was that in the 6-15 year age class, there was not a single stream or relief culvert problem. Since the only major difference in the construction methods of these two age classes was the improved standards from the state forest practice regulations, it is assumed that they played a significant role in the reduction of culvert related problems. In addition, this information shows that culverts designed for a 50-year flood event in this basin can adequately accomodate flows from a 100+ year flood event.

The road age category with the highest damage rate, .170 damage sites/km, was the 16-45 year group. Most of the problems occurred with steep cutslopes and with culverts, but shoulder failures and road slumps were also significant problems. Averaging a damage site every 5.8 km, these roads should be a prime candidate for some reconstruction.

The oldest age class of roads built over 45 years ago had a moderate damage rate of .092 damage sites/km, similar to the 6-15 year age class. The moderate damage rate is probably due to the partial reconstruction of these roads. If the puncheon culverts had been replaced during reconstruction, these roads would have had very few damage sites. Another reason for the lower damage rate is that the old railroad grades are on rather flat terrain where we would naturally expect less problems with soil movement.

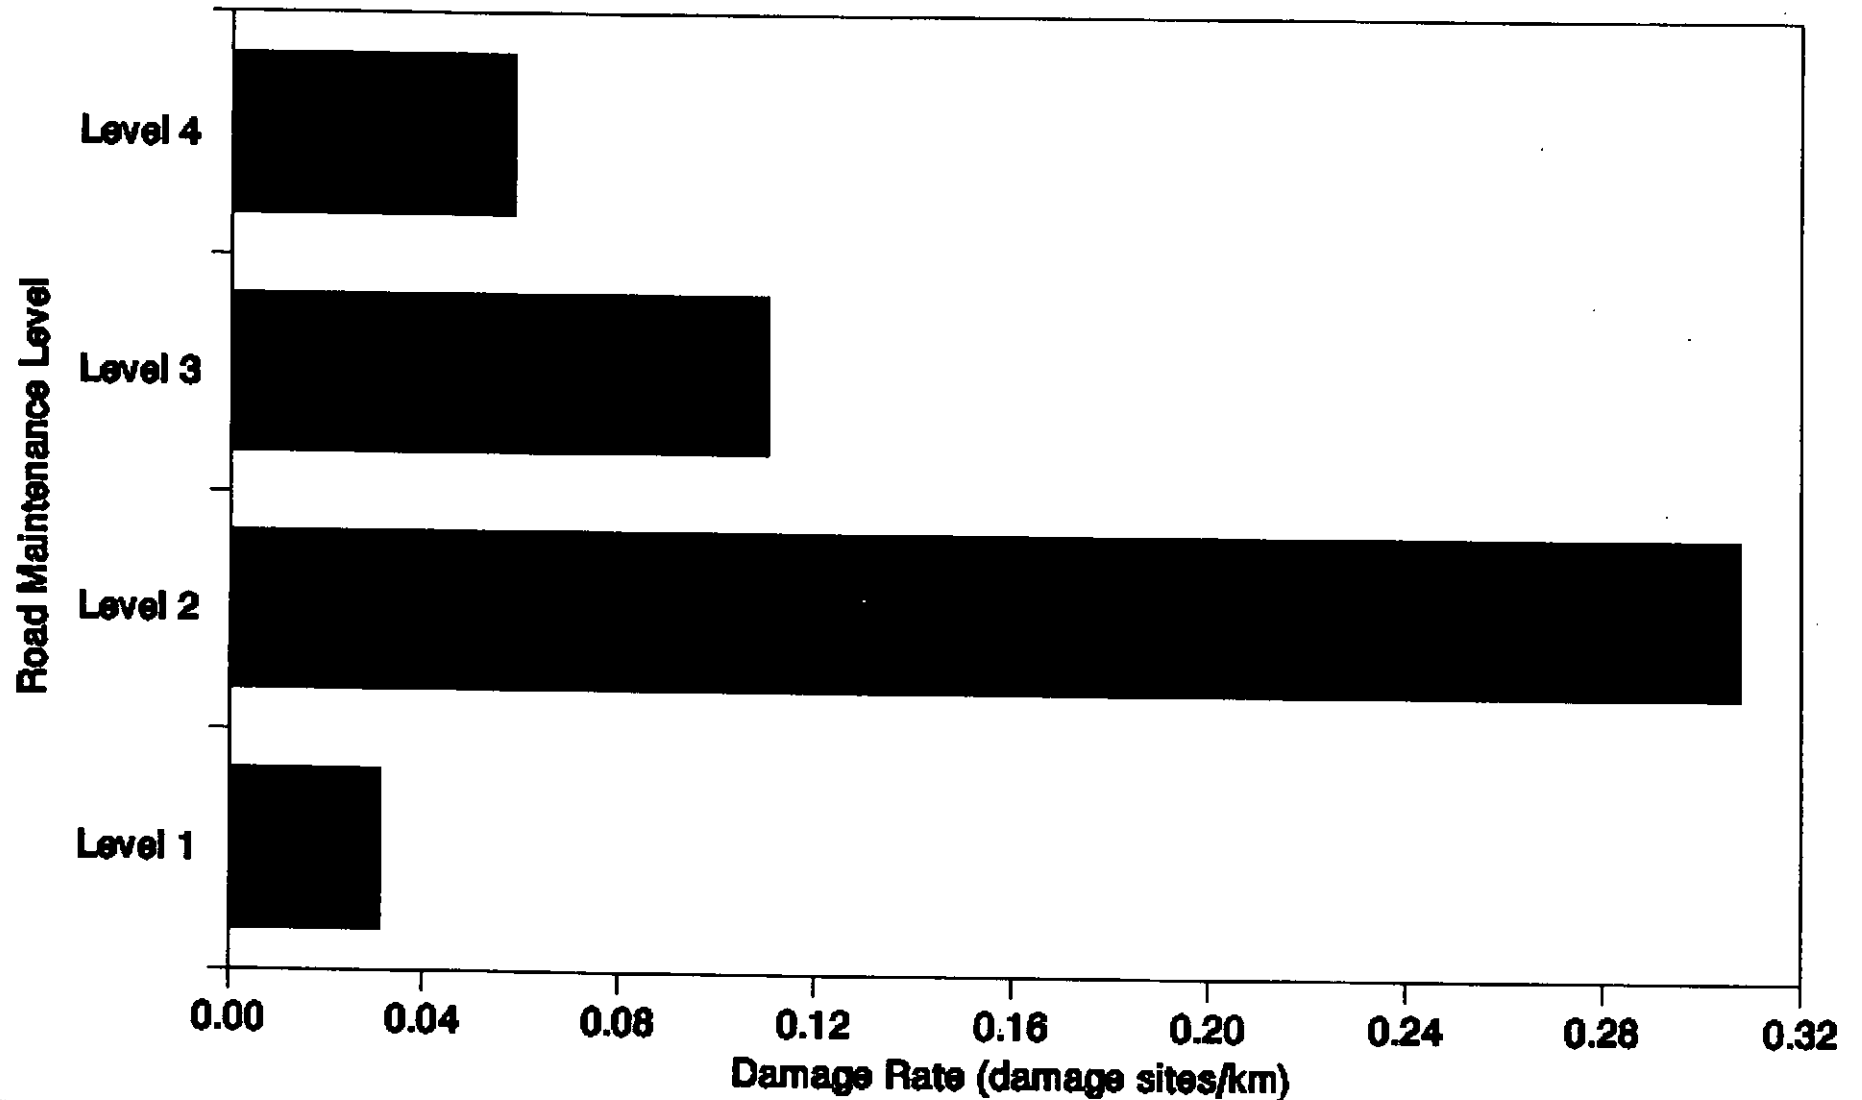
**Figure 12. Damage Rate by Road  
Maintenance Category**

Examining the information from the maintenance level map and the road damage form showed significantly different damage rates for each maintenance category (see figure 12). Level 1 roads averaged .031 damage sites/km, while level 2 roads averaged .308 damage sites/km. The damage rate for level 3 roads declined to .110 damage sites/km and for level 4 roads declined further to .058 damage sites/km.

One would expect the damage rate to decline progressively as maintenance increases, but level 1 roads seem to present an anomaly with its very low damage rate. One reason could be that most of

While the number of problems directly due to poor maintenance was low (17%), the fact that there is a progressive decrease in damage rate with better maintenance levels indicates it is of some importance. There is no record of how much damage was prevented by better maintenance, but the difference in damage rates between level 2 and 3 maintenance shows it was significant. One reason why railroad-grade roads might have fared better than expected was because they were all at either level 3 or 4 maintenance. This fact helps support the need for having a good road maintenance system.

Future road damage might be prevented if maintenance levels were based on sensitivity to problems, rather than just the amount of road usage. The sensitivity of a road could be addressed by considering some combination of road age and physical terrain

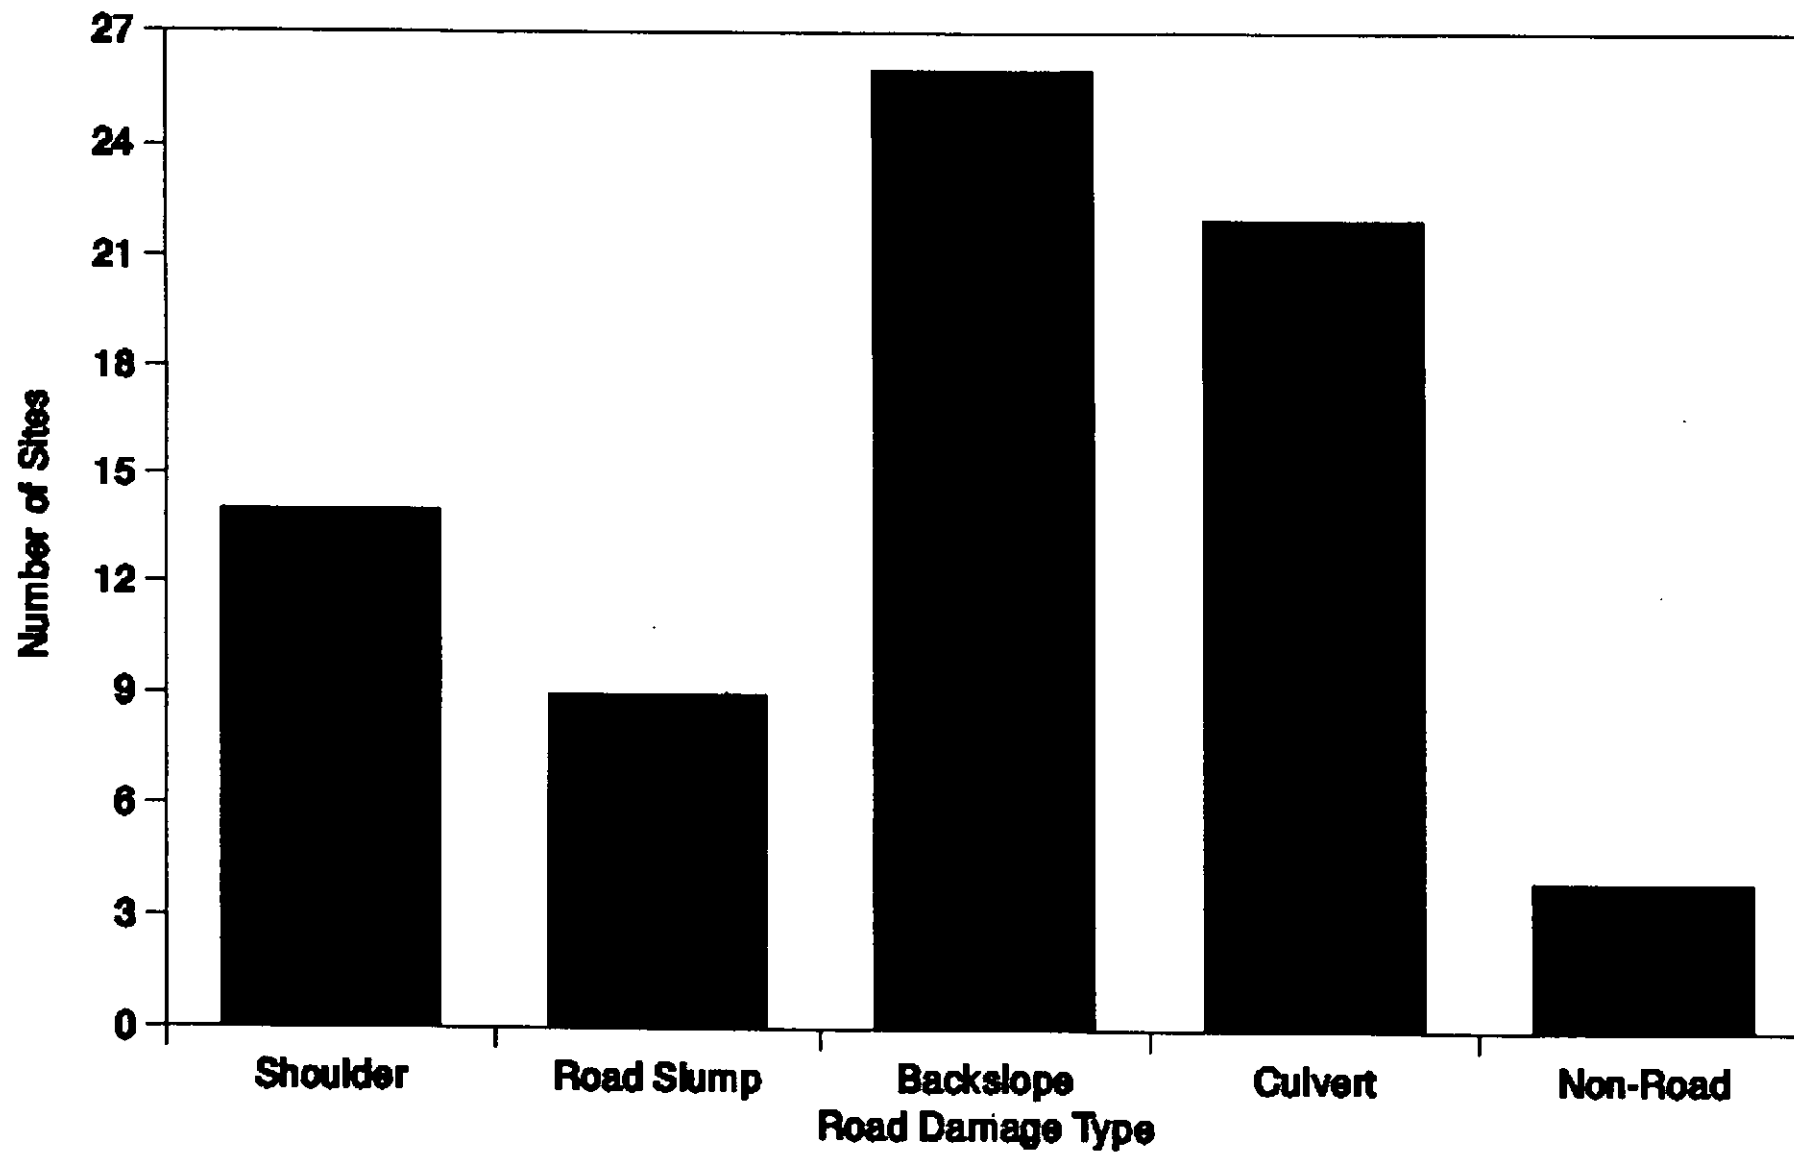
**Figure13.Frequency of Road Damage Types**

Figure 13 contains the frequency distribution of the different types of road damage. The largest number of problems (34%) were located in the backslope. Of these failures, 65% were due to steep cutslopes. The average cutslope angle for all backslope sites was 43.7 degrees. The presence of unstable soil significantly contributed to failures in 58% of the cases. Unstable soils were defined as either coarse grained granitic soils or weathered volcanic soils with a high clay content that occurred on slopes exceeding 35 degrees. These areas usually had a past history of slides that were visible on the surrounding hillslopes.

Steep backslopes accounted for the most road damage of any of the different failure types. The cause of this seems to be steep cutslope angles in areas of unstable soil. This was especially apparent in the Lincoln Creek watershed. Many times the failures would simply land on the road and just needed to be cleared away. Just as often, however, they blocked a ditch or culvert and more serious damage resulted.

Shoulder failures were another important problem comprising 18% of the sites. Excess sidecast on steep slopes was a significant factor in 93% of the shoulder failures. The average fill slope was 38.9 degrees. Twenty-nine percent of the failures caused significant environmental damage.

Road slumps accounted for only 12% of the sites. Seventy-eight percent of the problems were due to inadequate drainage. Unstable soil and fill on steep slopes were significant causes in 67% of these sites. One-third of the sites were responsible for environmental damage.

Reducing the cutslope angle in areas with unstable soils and a history of failures would be of great help. Much of the road system, though, has problems with steep cutslopes and it is not very practical to reduce the angle of every slope. Another more feasible alternative would be to pull the ditches out a bit so that

small failures and cutbank raveling do not immediately cause problems. Also, maintaining a good crown on the road would keep excess water from flowing onto sidecast material and reduce the chance of failure.

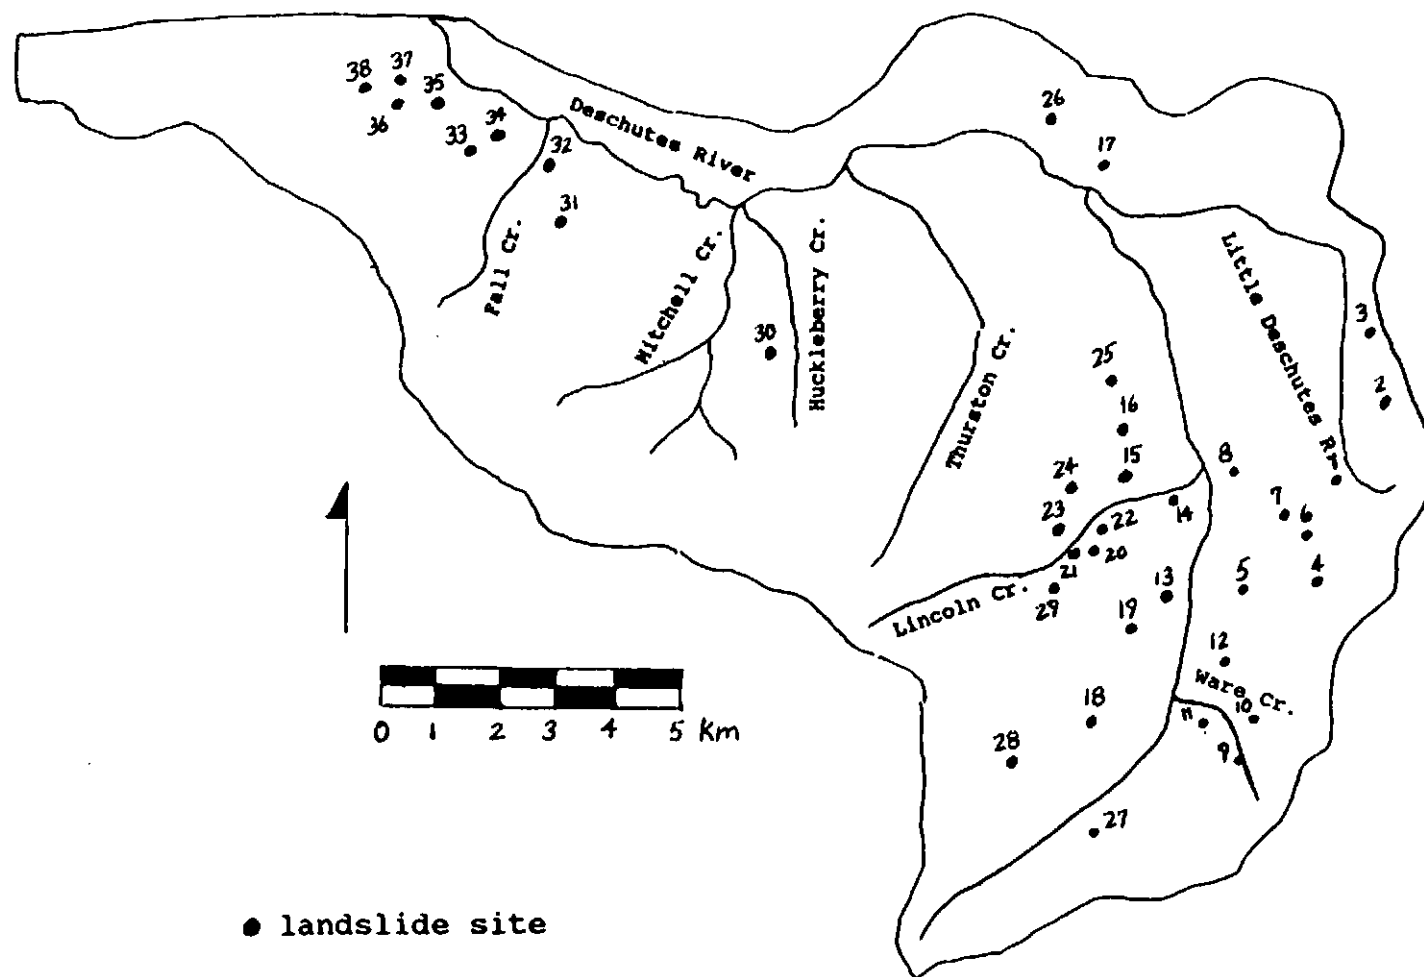
Figure 14. Landslide Inventory Sites

The landslide inventory data contained similar information to that collected in the road damage survey, but since the landslide inventory was a complete, non-biased sample, it was possible to do some statistical analysis. Figure 14 shows the location of the landslides and table 3 summarizes other information collected in the inventory. Two-thirds of the landslides in the sample were road related. There was no significant correlation between the origin of failure and the frequency of stream entry. The frequency of stream entry for both road and non-road related failures was approximately 60%.

results. For the sample as a whole, there was a significant difference in the frequency of slides between the younger and older stand age classes ( $\chi^2 = 11.4$ ,  $\alpha = 0.5$ ), with nearly 80% of the failures occurring in stands less than 16 years old.

If we divide the sample into road and non-road related groups, however, there is a significant difference. For non-road related failures, there is still a significant difference in the frequency of slides between stand age classes ( $\chi^2 = 8.33$ ,  $\alpha = 0.5$ ), but for the road related failures there is no significant difference. The results for non-road related failures agrees with other studies that have shown that as root strength diminishes, usually within 5-15 years after harvesting, the chances for failures greatly increases (Sidle et al., 1985). Stand age information, though, does not appear to be an important factor in determining the probability of road related failures.
