TFW Effectiveness Monitoring Report

**FOREST ROAD DRAINAGE AND EROSION INITIATION
IN FOUR WEST-CASCADE WATERSHEDS**

Curt Veldhuisen and Periann Russell

June 1999

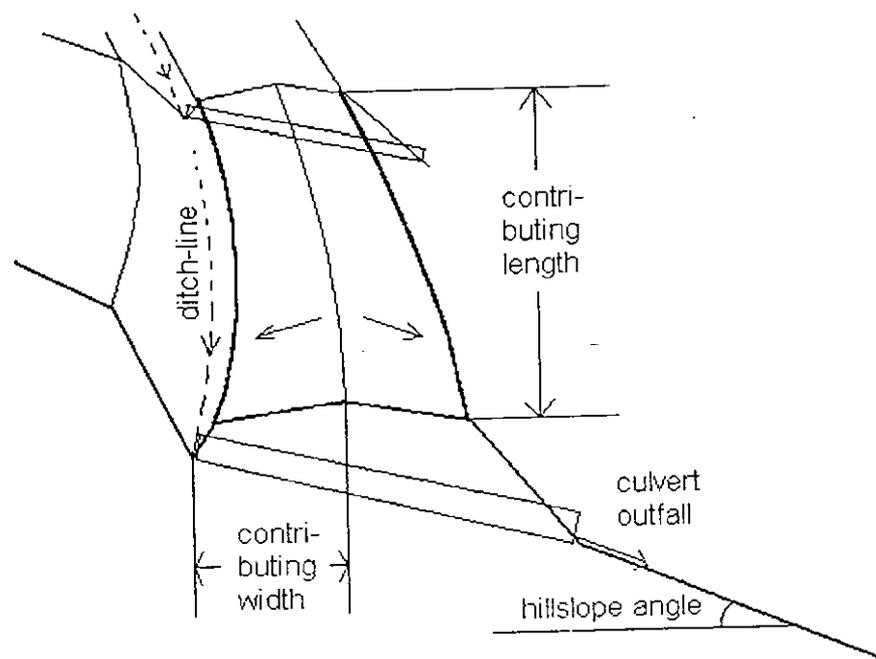
Figure 2. Illustration of typical drainage site: runoff is collected in an in-board ditch, then routed through a culvert onto the hillslope below. The road area that contributes surface runoff is equivalent to the contributing length multiplied by the contributing width. Because the tread surface in the case illustrated is crowned, only the inner portion of the tread contributes runoff to the ditch.

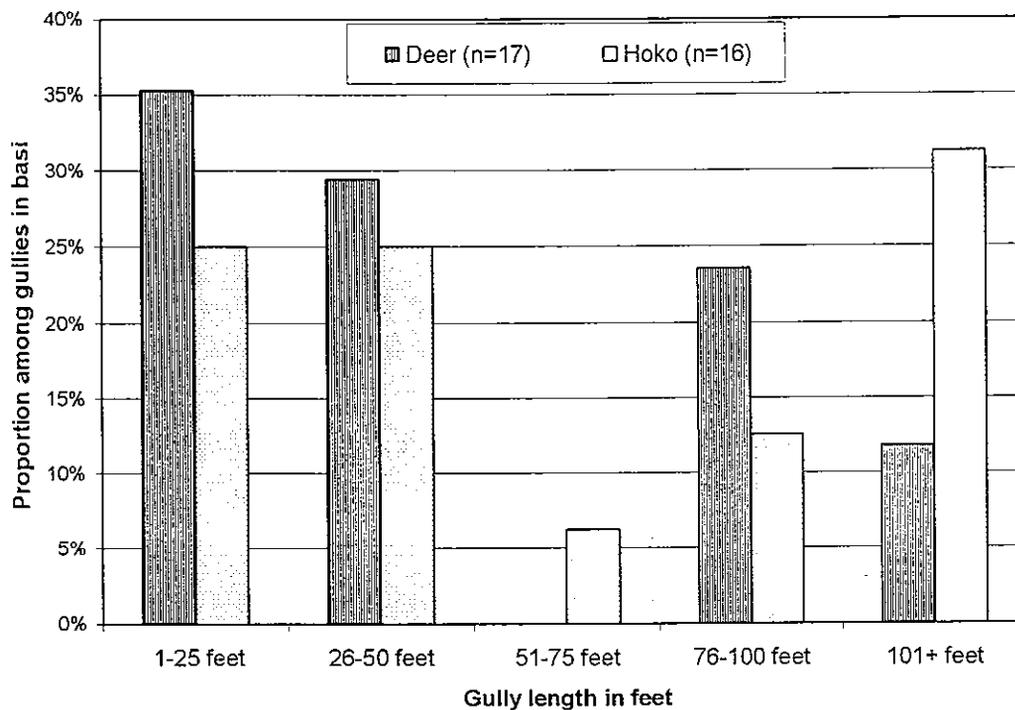
Figure 3. Distribution of gully lengths encountered in the Deer and Hoko road segments. Although most gullies are less than 60 feet long, a sizable minority extends substantially further downslope. The available gully lengths for the Mashel and Chehalis segments, though incomplete, suggest a similar trend.

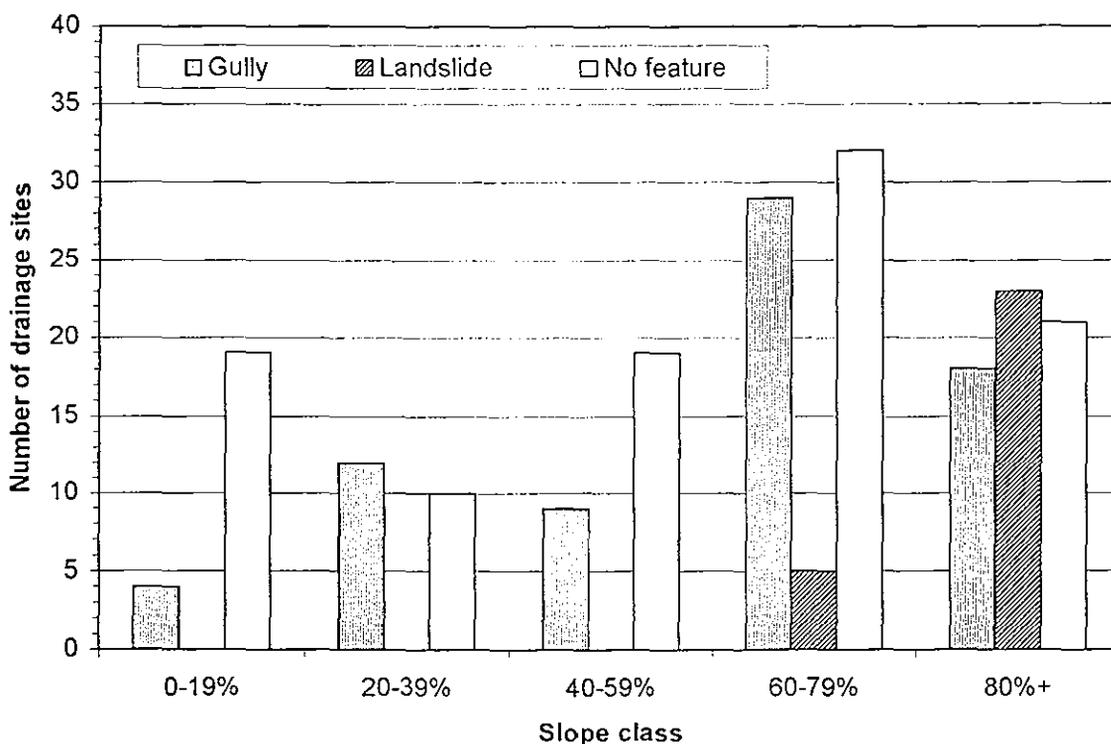
Figure 4. The proportion of sites with erosion features increases substantially relative to hillslope gradient. In particular, note that most landslides were associated with slopes of 80% and greater. A positive correlation is apparent between slope gradient and gullying, but is less consistent.

Among the combined data set, the frequency of erosion features increases strongly with increasing hillslope gradient at the drainage release point (Figure 4). On slopes less than 60%, gullies were found at approximately one third of drainage sites, though no landslides were encountered. The occurrence of gullies and the absence of landslides suggest that this gradient range is insufficiently steep for soil to slide, even with the contribution of road runoff. Gullies are least frequent within the gentlest slopes (0-19%), but occur commonly on slopes between 20 and 59%. On slopes of 60% or greater the frequency of gullies increases substantially, and landslides are found at a number of sites. Landslide frequency increases substantially for sites involving slopes exceeding 80% (Figure 4), the range which contained the greatest total erosion response.

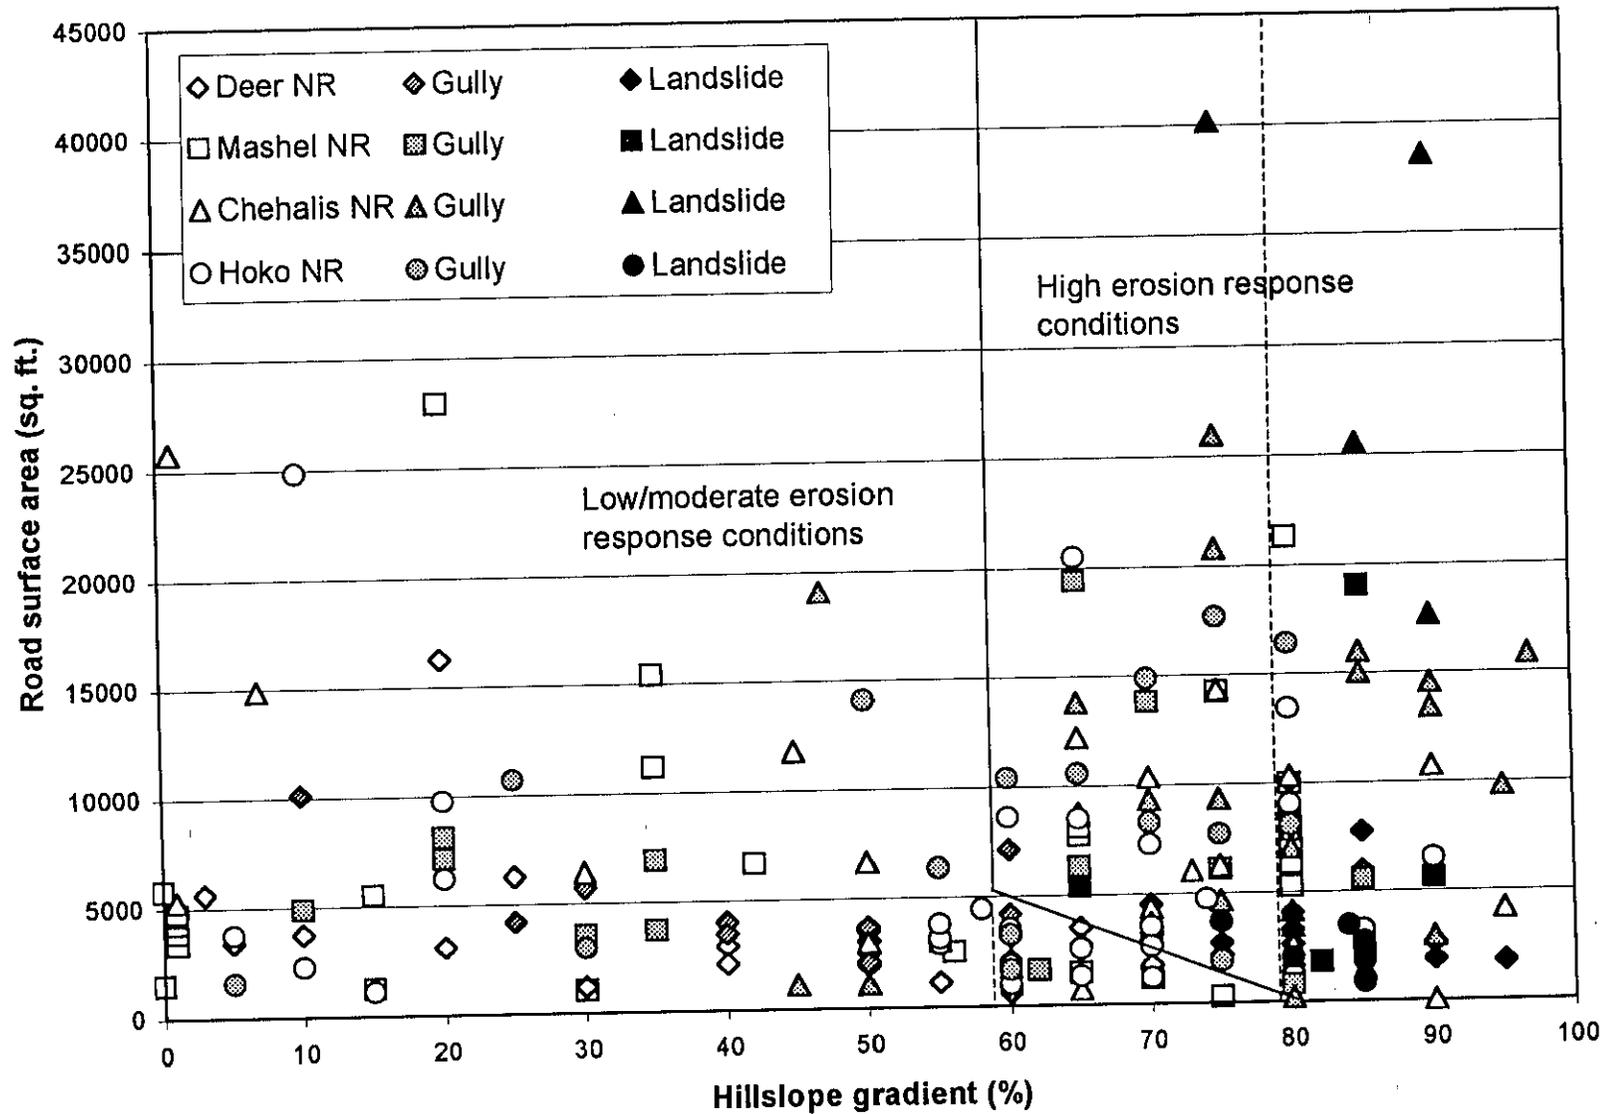
Figure 5. Plot of slope vs. road surface area of drainage sites from all four WAUs. The marker shape indicates the watershed (see legend). The marker fill indicates the erosion response: hollow markers had no erosion response ("NR"), gray-shaded centers indicate a gully, while solid centers indicate a landslide. Four outlier points are not within range of values shown.

For sites with slopes of 80% and greater, the many gullies and landslides were found across the range of slopes and road surface areas sampled (Figure 5). Given that undisturbed slopes of 80% and greater are normally considered to be marginally stable, it is also notable that nearly one-third had no erosion feature (including the study's steepest site at 120%!), even with the addition of road drainage water. Such sites may remain stable due to rapid infiltration and dispersal of road runoff, or the presence of very rocky soils with a high angle of repose. Despite these exceptions, these data illustrate that release of road runoff onto slopes of 80% or greater, whether deliberately or not, is quite likely to initiate erosion.

One surprising observation from Figure 5 is that numerous gullies occur at drainage sites characterized by both low slope gradients and relatively small road surface area. We suspect that many of these gullies result from supplementation of road surface runoff with inputs from interception of shallow groundwater. As shown in Figure 6, many of the low gradient erosion sites with small surface areas occurred below ditches observed to receive seepage inputs. This suggests that the addition of subsurface flow may substantially increase the likelihood of gully erosion at the release point. The added flow from seepage appears to have the greatest effect on slope gradients below 60%, where seeps were associated with three-fourths of the erosion features encountered. Cutslope seepage contribution was associated with numerous erosion features on high slopes as well, including many with low road surface areas (Figure 5). However, because half of the erosion features on higher slopes had no seepage contribution evident, we conclude that road surface runoff alone is commonly sufficient to trigger erosion.

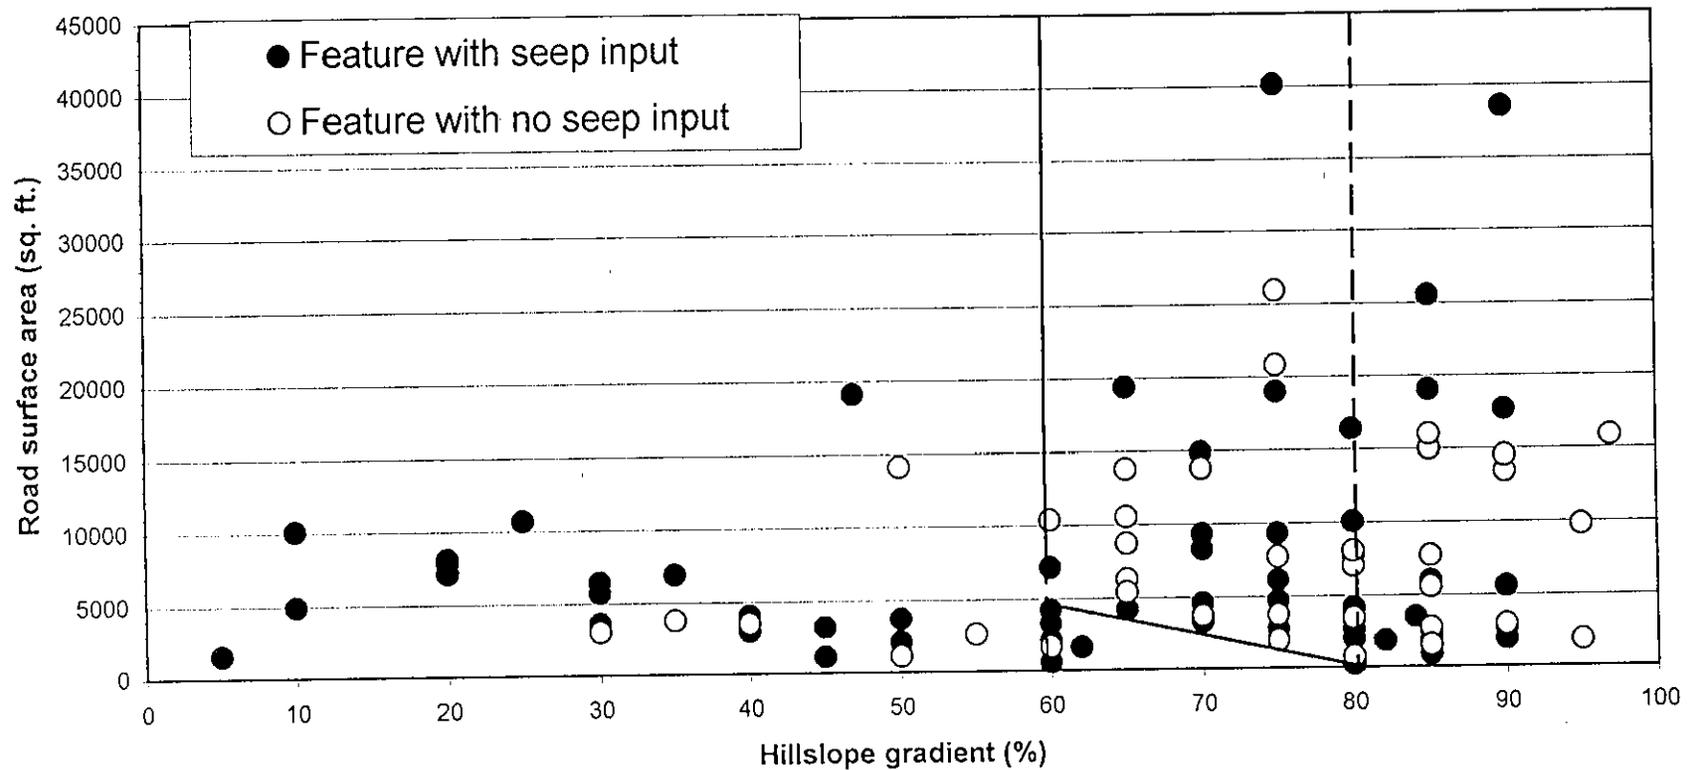
Figure 6. Slope/area plot of drainage sites with an erosion feature that shows the influence of seepage inputs. Note that most erosion sites with relatively small road surface area had seepage contribution, including 65% of the sites with less than 10,000 square feet of contributing road surface area.

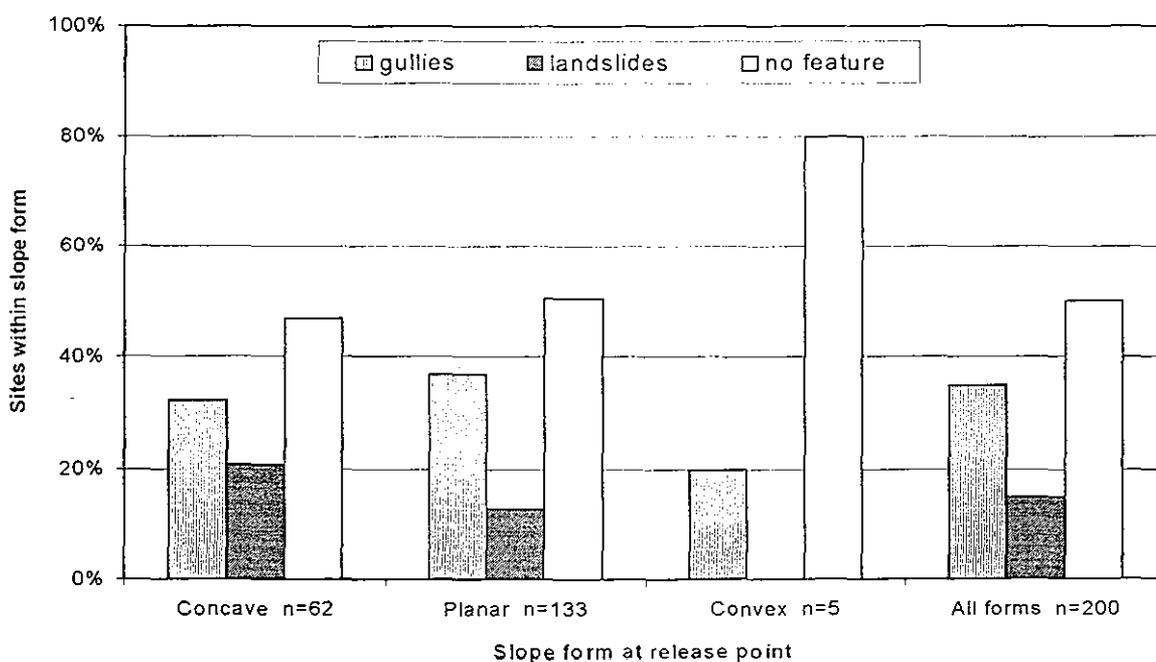
Figure 7. Erosion response among drainage sites involving concave, convex and planar slope forms. Gullies were found on all slope forms, while landslides were most common on concave or planar slopes. Note that the sample size of convex drainage sites was very small.

The fact that gullies were found at about one third of both concave and planar sites (Figure 7) indicates limited sensitivity of gully formation in response to slope form. Landslide rates showed a greater response toward slope form, occurring at 21% of concave sites, in comparison to 13% of planar slopes and none on convex (Figure 7). Despite these differences in response rate, landslides on planar slopes account for 57% of all landslides encountered, due partly to the overall prevalence of planar slopes among release sites. Still, the number of landslides found on planar slopes was somewhat surprising, since most Watershed Analyses emphasized concave slopes as the dominant slope form associated with road failures.

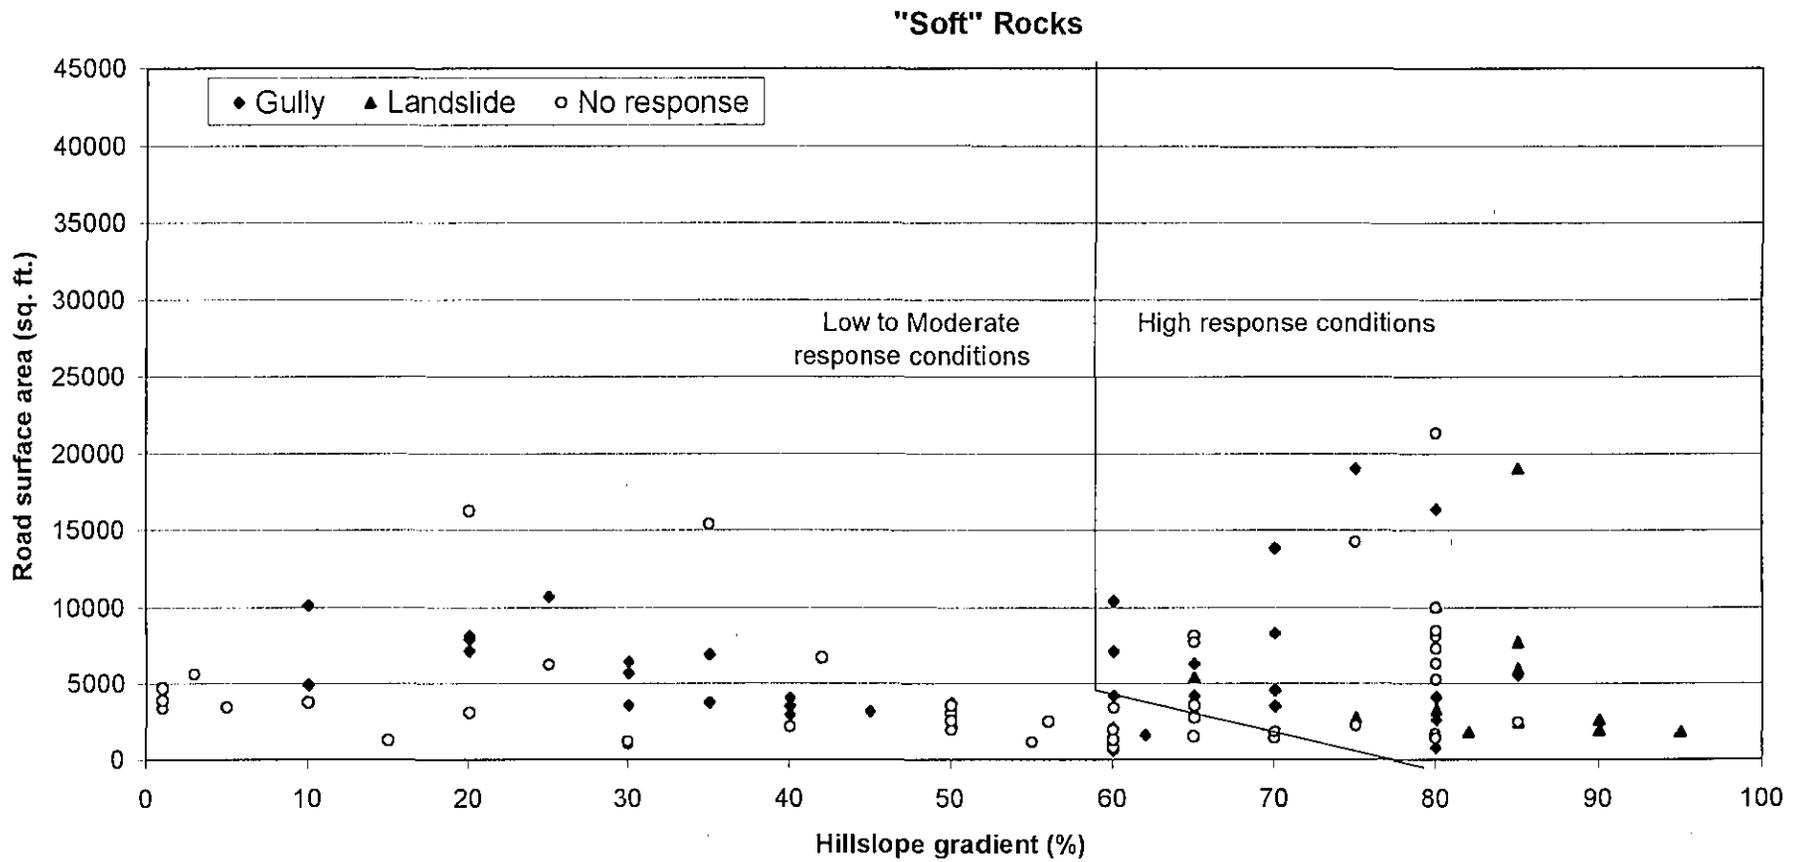
Figure 8. Slope/area plot of erosion response at sites in soft geologic materials, such as glacial sediments, sedimentary and interbedded sedimentary/volcanic rocks.

Again we found that the slope/area plots for the soft (Figures 8) and hard strength groups (Figures 9) generally follow the patterns described previously for all drainage sites (Figure 5). For sites on slopes exceeding 80%, erosion features are common in either strength group and include most of the landslides encountered. However, among sites where slopes are less than 80%, several differences were noted between geologic materials that justified further analysis.

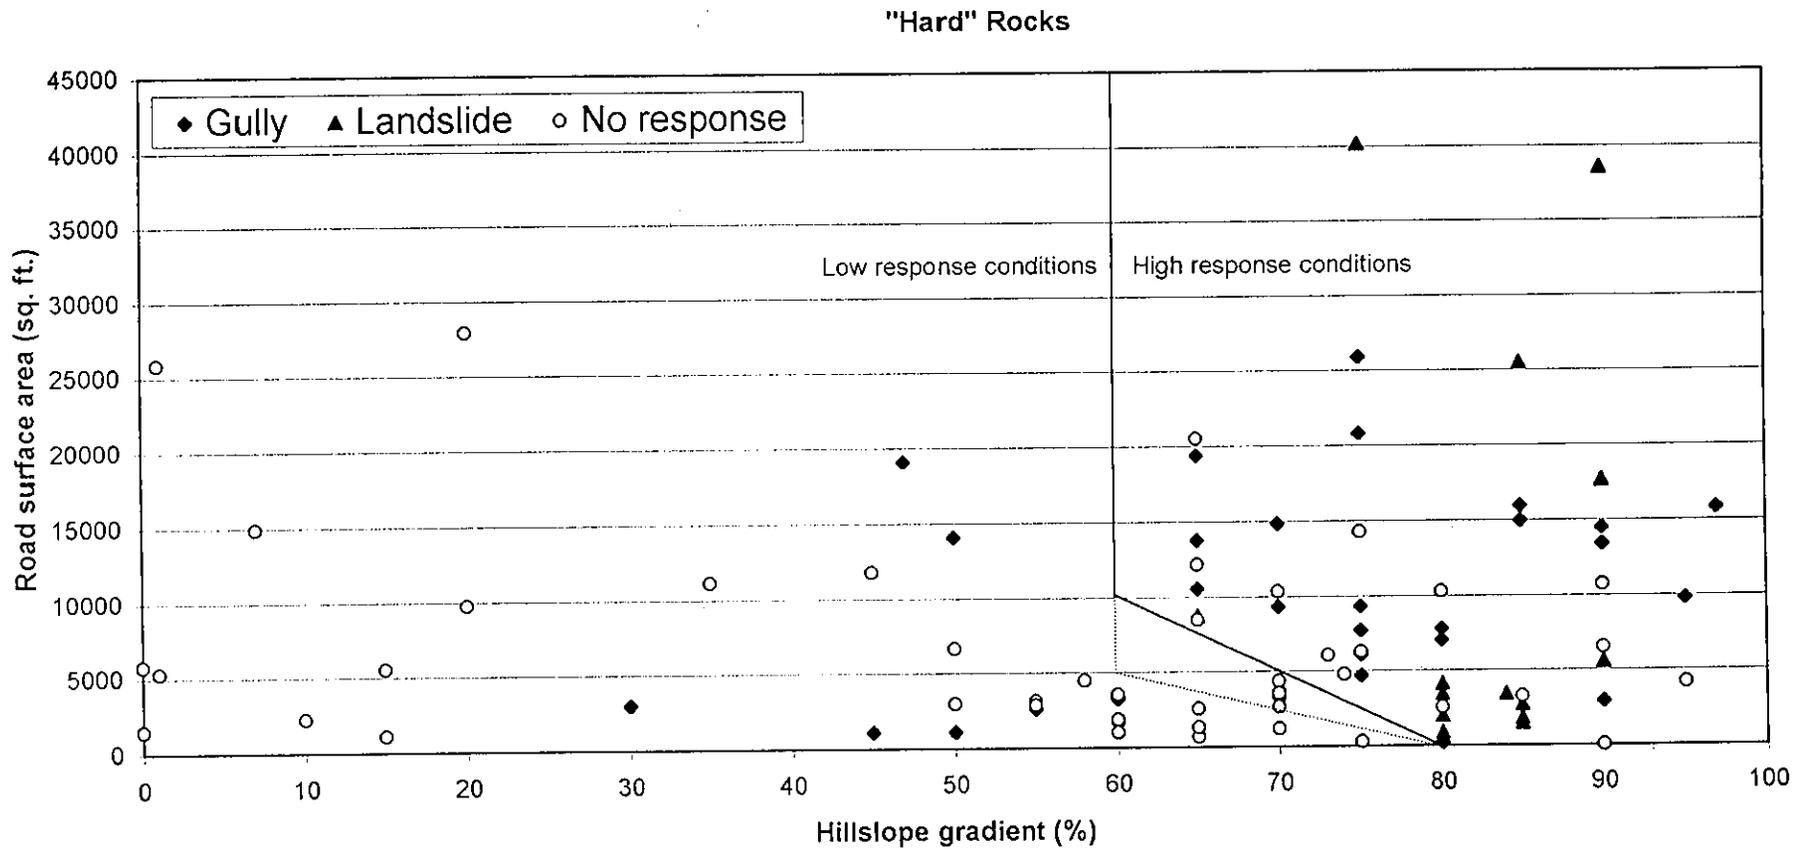
Figure 9. Slope/area plot of erosion response sites in “hard” geologic materials, such as basalt and breccia. For slopes of 60-79%, the road surface area required to trigger erosion is greater compared to sites in soft materials (Figure 8). Two outliers are not shown, both sites with no erosion response.

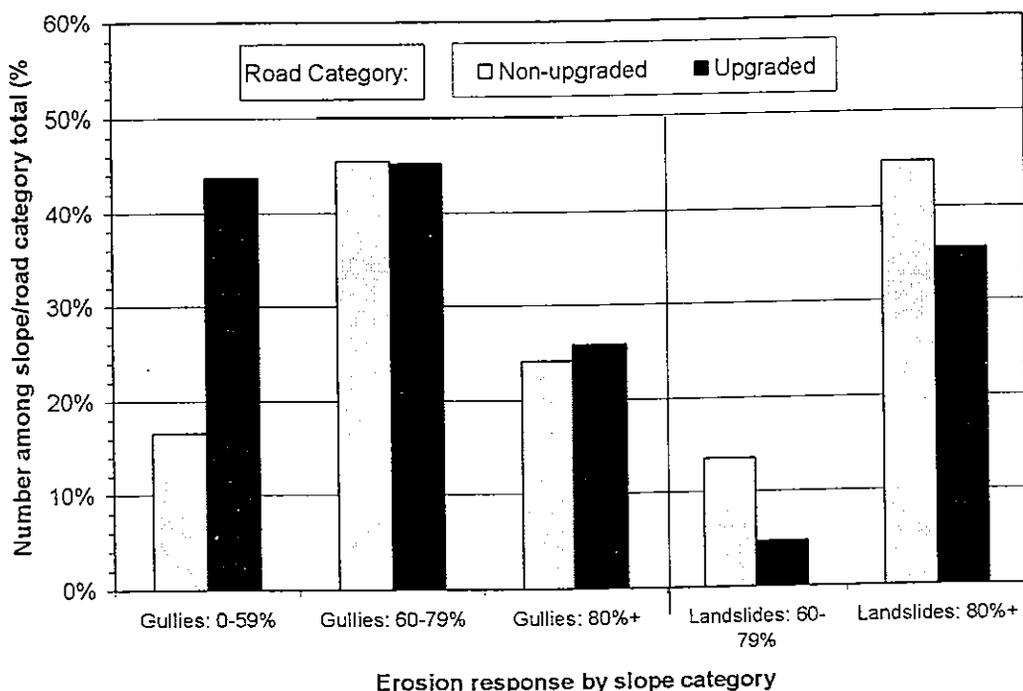
Figure 10. Comparison of the frequencies of erosion features among older roads where drainage systems have been upgraded vs. non-upgraded. Comparisons are between drainage sites within each of three slope categories. No landslides were found at any site within the 0-59% slope range.

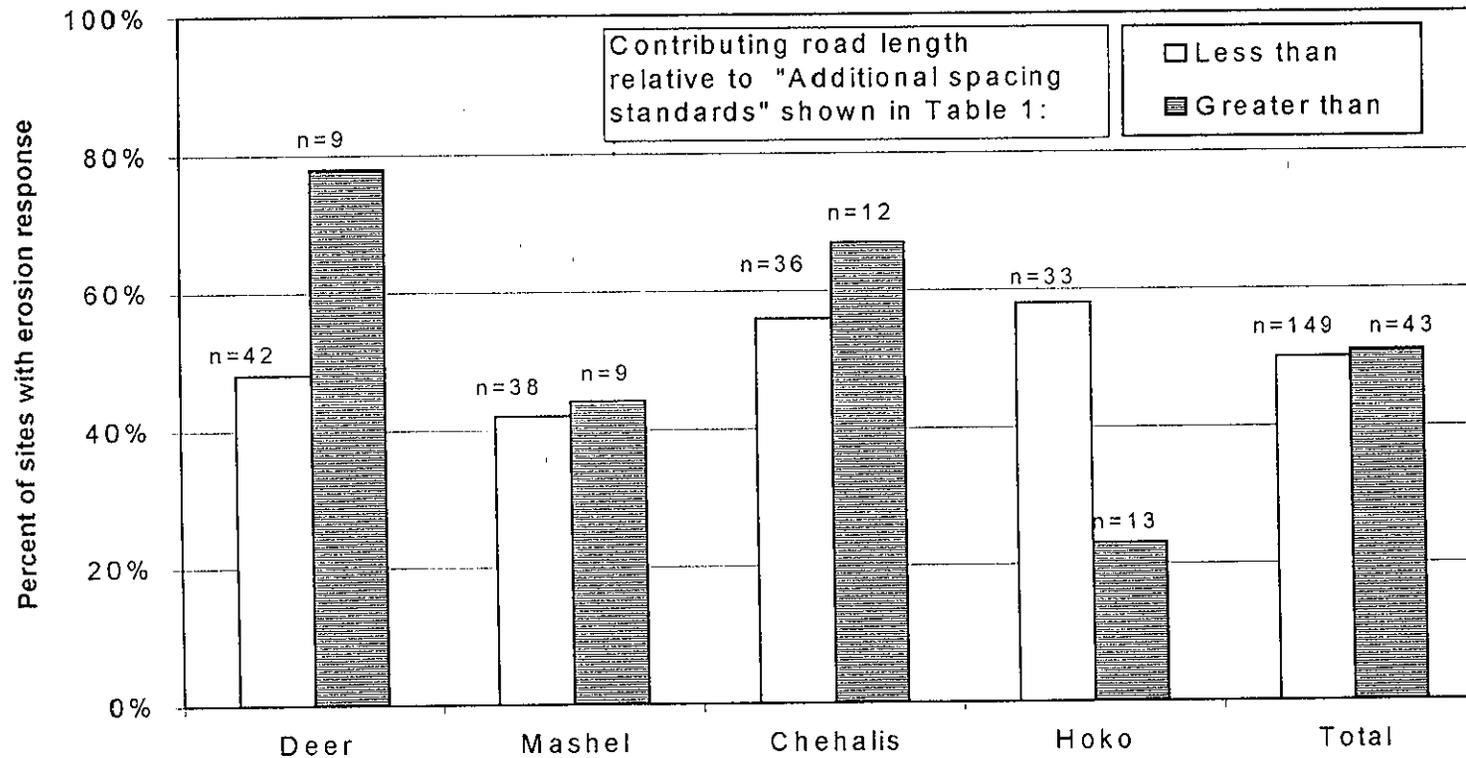
Figure 11. Erosion responses for drainage sites where cross-drain spacing was less than vs. greater than spacings specified in the "Additional culvert spacing recommendations" in Forest Practice Rules (WFPB 1995). The erosion response rates shown in these comparisons are inconsistent among the individual WAUs, and nearly the same for the combined group. Values for "n" indicate the number of drainage sites in each category.

Our analysis found minimal evidence that erosion response differed substantially on the basis of compliance with the Additional spacing rule. Among the comparisons made for drainage sites within each WAU, results were notably inconsistent (Figure 11). Erosion rates for sites out of compliance were similar but slightly higher among Mashel and Chehalis sites, considerably higher among Deer sites, but considerably lower for Hoko. The comparisons among sites in all WAUs found essentially the same proportion of erosion features among sites in compliance (50%) relative to those out of compliance (51%). Further perspective is given by the observation

that 75% of the total sites with an erosion feature were sites in compliance with the strictest standard spacing rules. Together, these results suggest that present cross-drain spacing standards are generally ineffective at preventing erosion below drainage release sites. Because erosion response was closely associated with hillslope gradient among all the watersheds monitored (Figure 4), we see little potential for reducing erosion by simply adjusting the existing road-gradient-based guidelines. Rather, our findings support a secondary set of hillslope-gradient-based guidelines to identify and guide drainage practices at drainage sites where the existing guidelines would be inadequate, as is further discussed in detail in the Management Conclusions and Recommendations section.
