**EFFECTS OF LANDSLIDE-DAM-BREAK FLOODS  
ON CHANNEL MORPHOLOGY**

A thesis submitted in partial fulfillment of the requirements for the degree of

University of Washington

1991

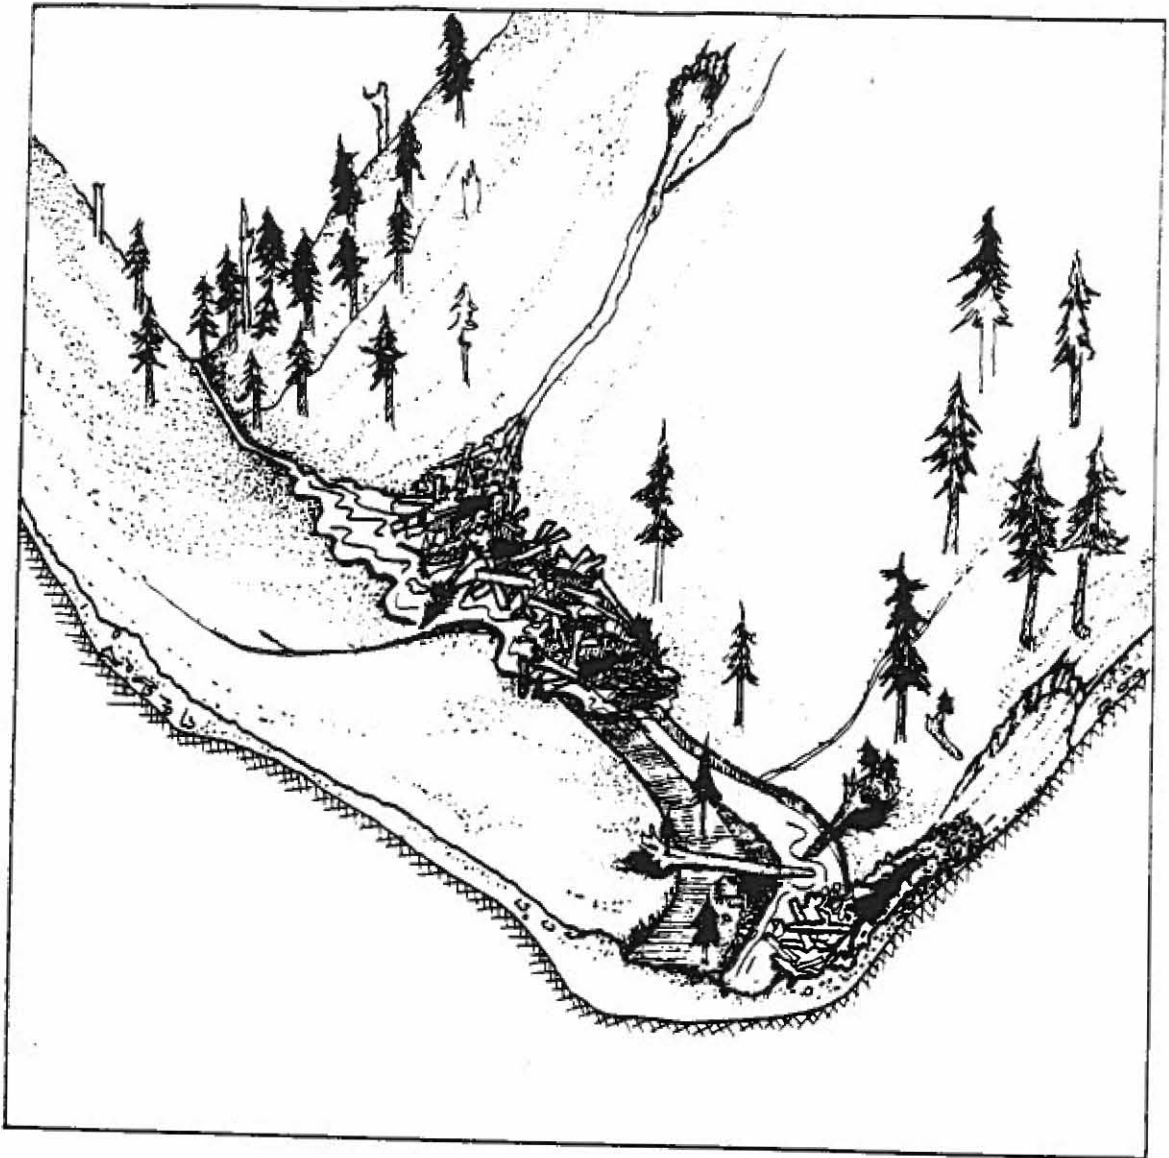
Figure 26. Illustration of a debris flow moving into a steep, first-order channel and depositing in a third-order channel. Deposition of the debris flow creates a dam that impounds water. When the dam is breached, a flood wave moves into the valley below.

The dam-break floods on Camp, Huckleberry, and Pistol Creeks were caused by the failure of dams formed from debris flow deposits (Fig. 26). The debris flows at all three sites began as failures of road sidecast on bedrock hollows and moved rapidly into first-order or second-order channels.

Failure of the dams resulted in flood waves (Fig. 26) that traveled distances that do not correlate to either the initial dam height, width, or lake volumes. The length of the flood wave varies from 330 m to 3.3 km.
