**DAM-BREAK FLOODS IN  
LOW ORDER MOUNTAIN CHANNELS  
OF THE PACIFIC NORTHWEST**

**Project Completion Report for the Award  
"An Examination of the Forms of Initiation of  
Floods From the Breaching of Non Engineered Dams"  
Administered by the State of Washington  
Department of Natural Resources  
Timber Fish & Wildlife  
TFW-SH9-93-001**

**Water Resources Series  
Technical Report No. 138**

**June 1994**

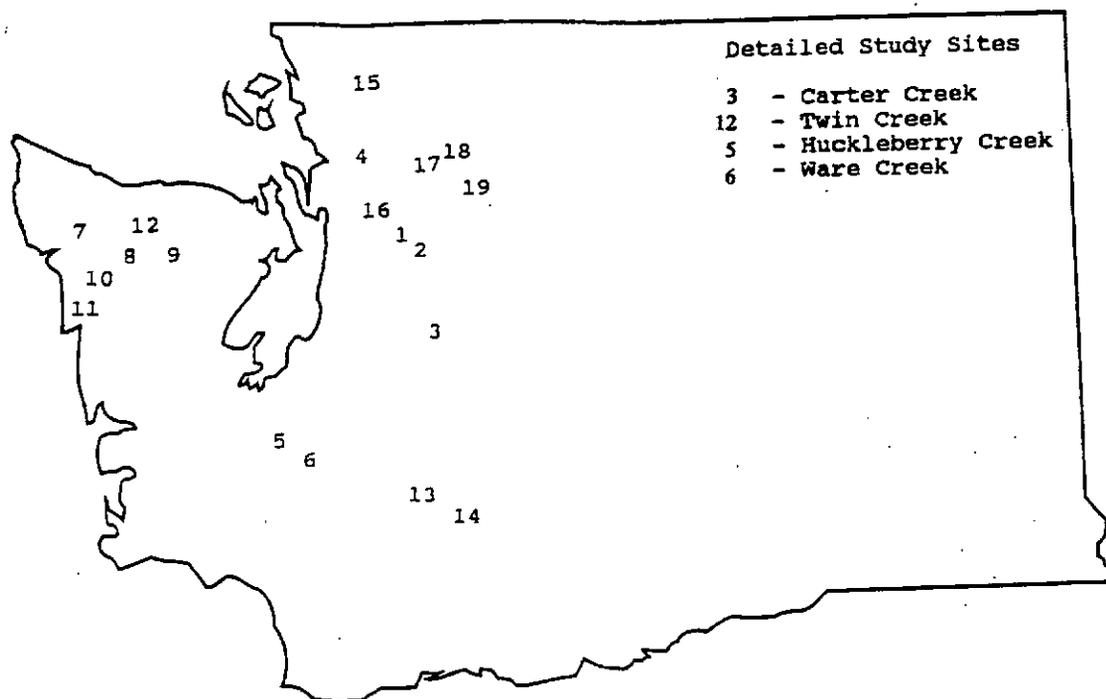
Fig. 1.3 Locations of investigated dam-break floods within the State of Washington.

More detailed investigations were conducted at four sites: Carter, Huckleberry, Twin, and Ware Creeks, shown respectively as 3, 12, 13, and 14 in Figure 1.3. Carter Creek and Ware Creek were chosen for detailed investigation because both experienced dam-break floods that were initiated by breaching of organic dams within the stream channels; mass wasting was not involved. Huckleberry Creek was chosen because of the large size of the organic dam that resulted from a small dam-break upstream. Twin Creek was chosen because it was the only site found where there has been no timber harvesting. At all sites, particular attention was given to the presence or absence of woody debris in

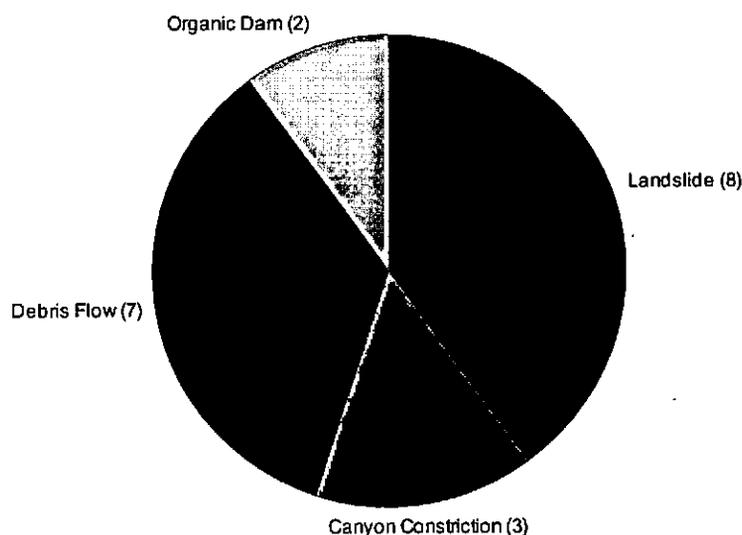
Fig. 3.1 Number of dam-break sites and corresponding initiation modes.

According to the present, limited, inventory of dam-break floods, landslide and debris-flow deposits were the primary method of initiation in managed forests. These two mechanisms accounted for 75% of the failures.

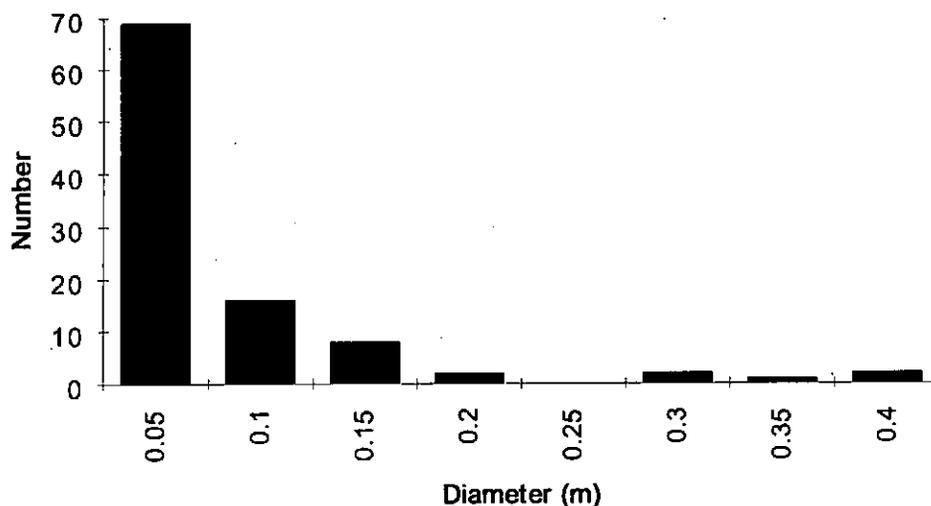
Fig. 3.2 Relative frequency of diameters of debris in Carter Creek immediately upstream of the initiation site, (n=100), class interval 0.05 m.

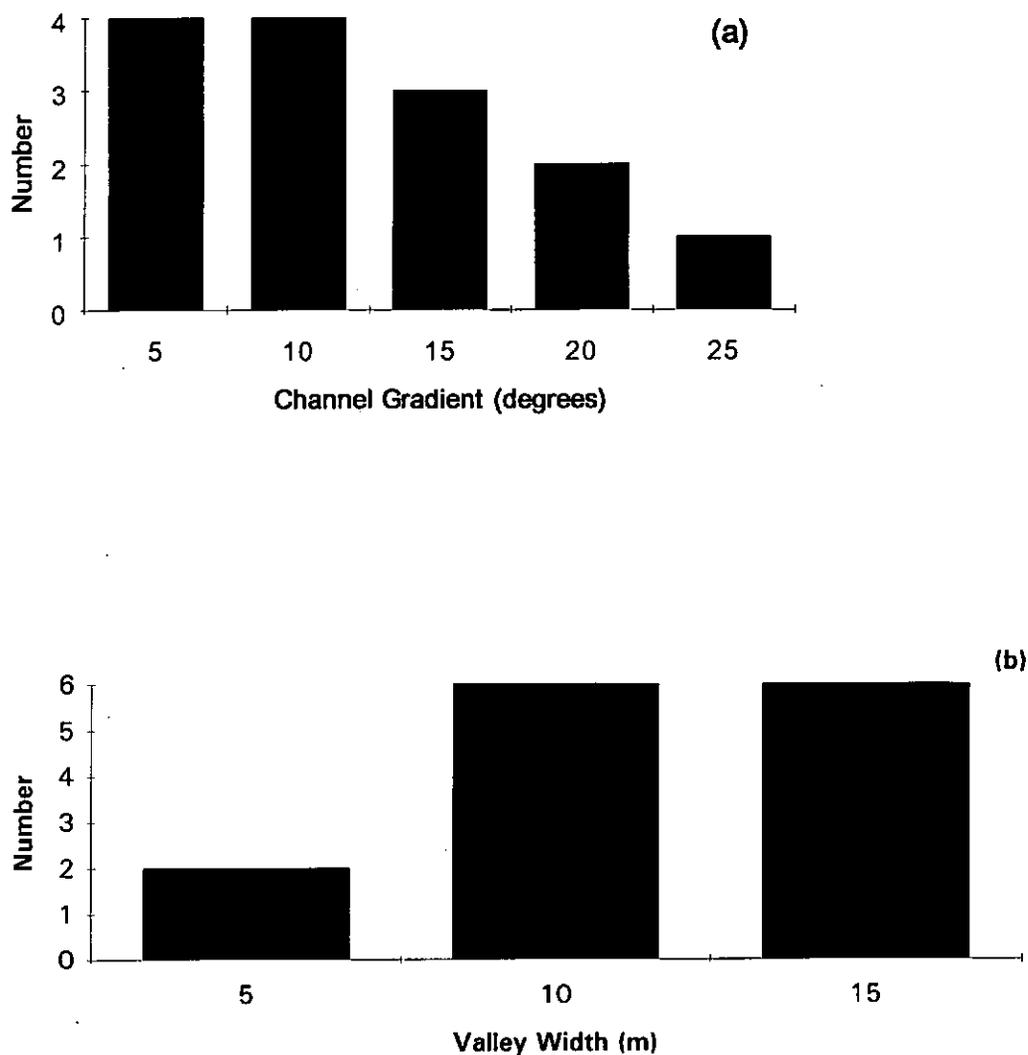
Fig. 3.3 Number of dam-break initiation sites having corresponding (a) channel slopes, and (b) valley widths. ( $n = 14$ , channel gradient class interval  $5^\circ$ , valley width class interval 5 m.)

The distributions of channel gradients and valley widths at initiation sites in which both of these data were collected are plotted in Figure 3.3. Based on observations at twenty sites, a locally low gradient and narrow valley are conducive to dam formation. The low-gradient data are in agreement with Benda and Cundy (1990), who found that relatively low channel gradients less than  $20^\circ$  are necessary for deposition of landslides and debris flows, and thus dam formation; higher channel gradients may cause the flow to continue to travel down the valley, thereby precluding dam formation.

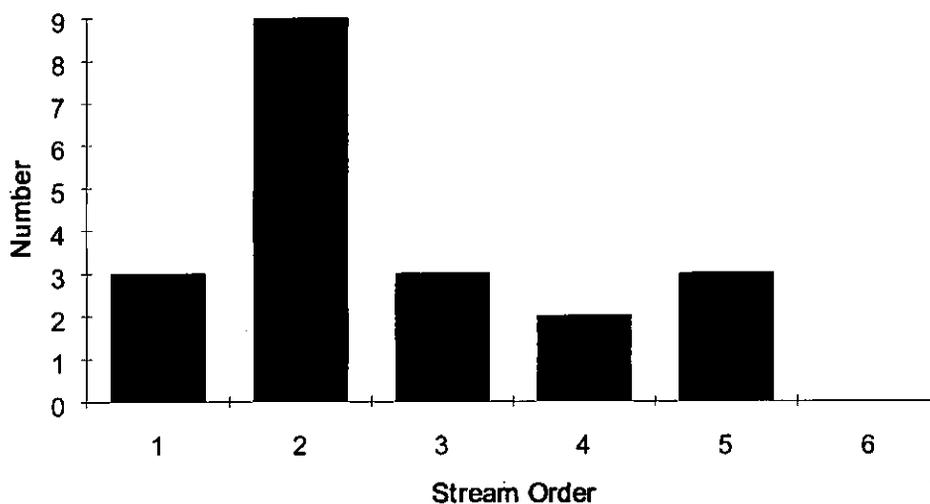
Fig. 3.4 Number of streams of order  $m$  where dam-break initiation occurred ( $n = 20$ ).

The frequency distribution of order of streams at the initiation sites of dam-break floods is presented in Figure 3.4. The distribution of order at initiation appears to

be positively skewed. Values range from first- to fifth-order, with a mode of second order. This supports the earlier findings with respect to channel gradient and width. The narrower, steeper channels, typical of low-order streams, are the most common sites for dam formation.

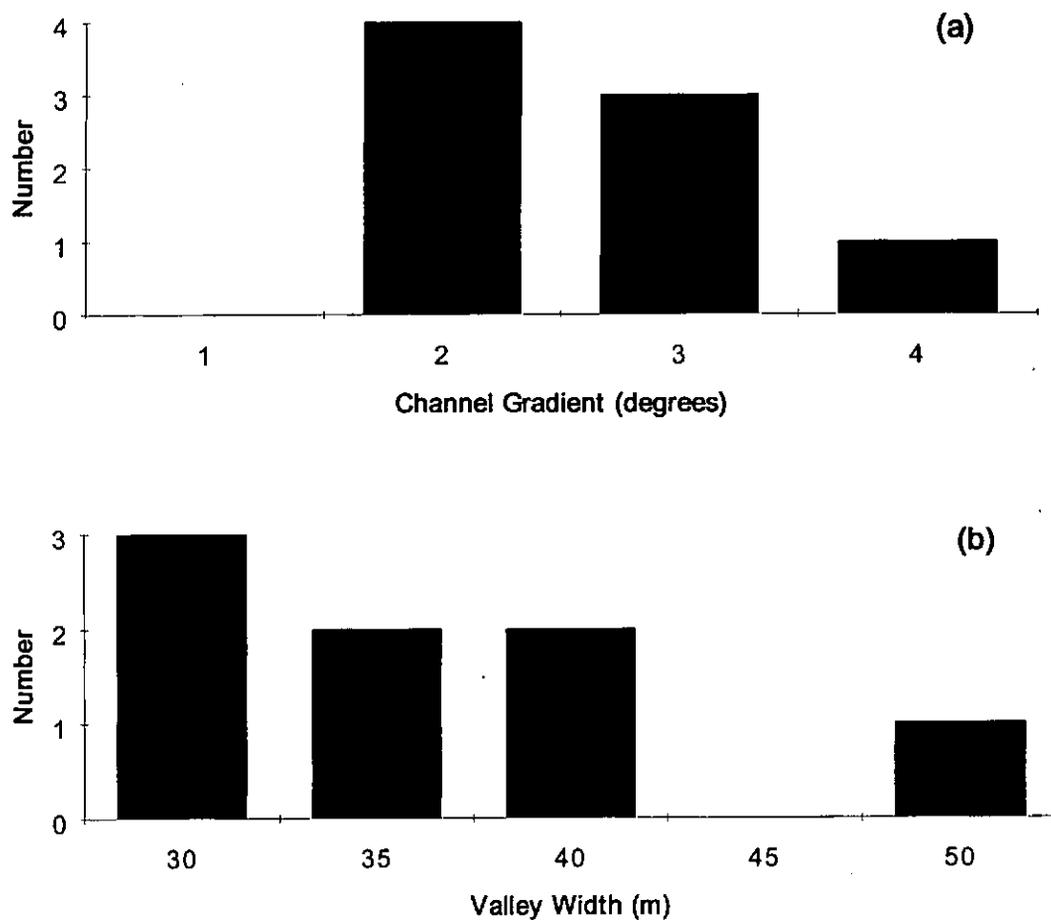
Fig. 3.5 Number of dam-break deposition sites with respect to (a) channel slopes (class interval  $1^\circ$ ), and (b) valley widths (class interval 5 m), ( $n = 8$ ).

The distributions of channel gradients and valley widths at the 8 deposition sites in which both these characteristics were identifiable from debris remnants are plotted in Figure 3.5. The channel gradient at deposition sites is approximately  $2^\circ$  to  $3^\circ$ . Valley width at deposition ranged from 30 to 50 m. For the 14 sites where the channel gradient (but not the valley width) at the debris dam deposition location could be identified clearly, seven occurred where the local channel slope was  $3^\circ$  or less. Six deposition sites had a local channel slope between  $2^\circ$  to  $3^\circ$ . At the bulk of these sites the channels had stream orders of three and four and the valley widths were largely between 30 and

40 m. The corresponding upstream initiation widths were typically on the order of 10 to 15 m.

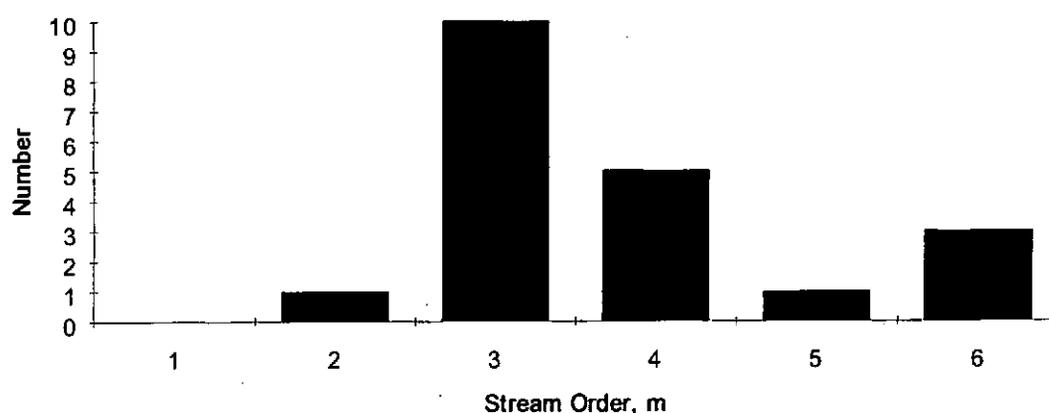
Fig. 3.6 Number of streams of order m where dam-break deposition occurred (n=20).

was deposited in a second-order channel. Three floods deposited debris in sixth-order channels. The positive shift of this distribution with respect to the distribution of stream order at initiation can be explained by wider and lower gradient channels characteristic of higher order streams. The channel geometry in these higher-order streams does not support dam formation or sustenance of moving debris.

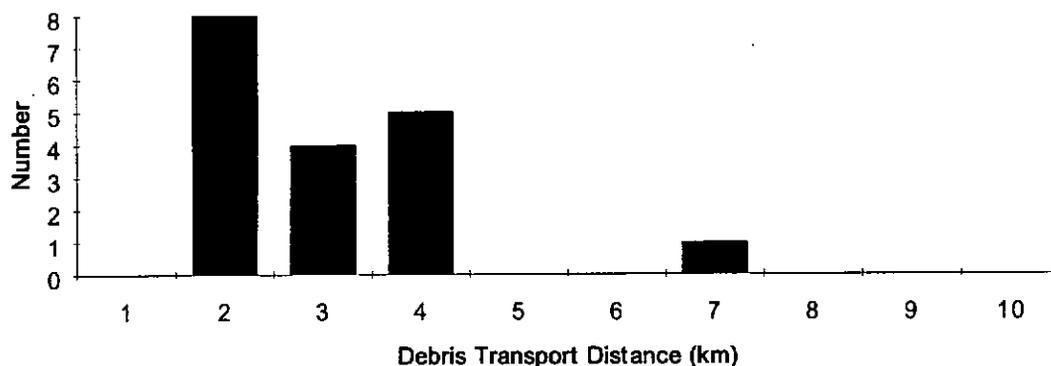
Fig. 3.7 Number of dam-break floods versus debris transport distance (class interval 1 km,  $n = 18$ ).

The number of dam-break floods and their corresponding travel distances over which they transported organic debris are shown in Figure 3.7. Most of these floods traveled between 2 and 4 km. The controlling factor in travel distance is most likely the valley geometry. It seems that the movement of the organic debris dams progress until the gradient decreases to  $2^\circ$  to  $3^\circ$ , and the valley widens to at least 30 meters and is unable to contain the previously impounded water as the debris moves into the wider channel.

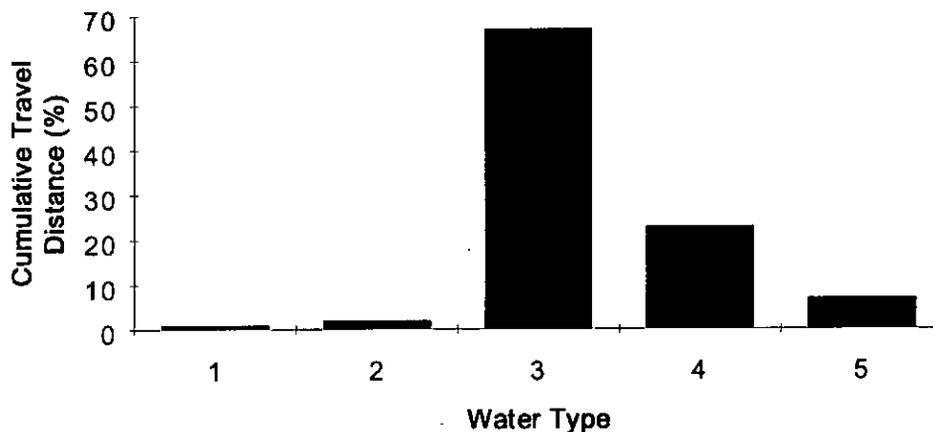
Fig. 3.8 Percentage of cumulative travel distance versus Washington Department of Natural Resources water type.

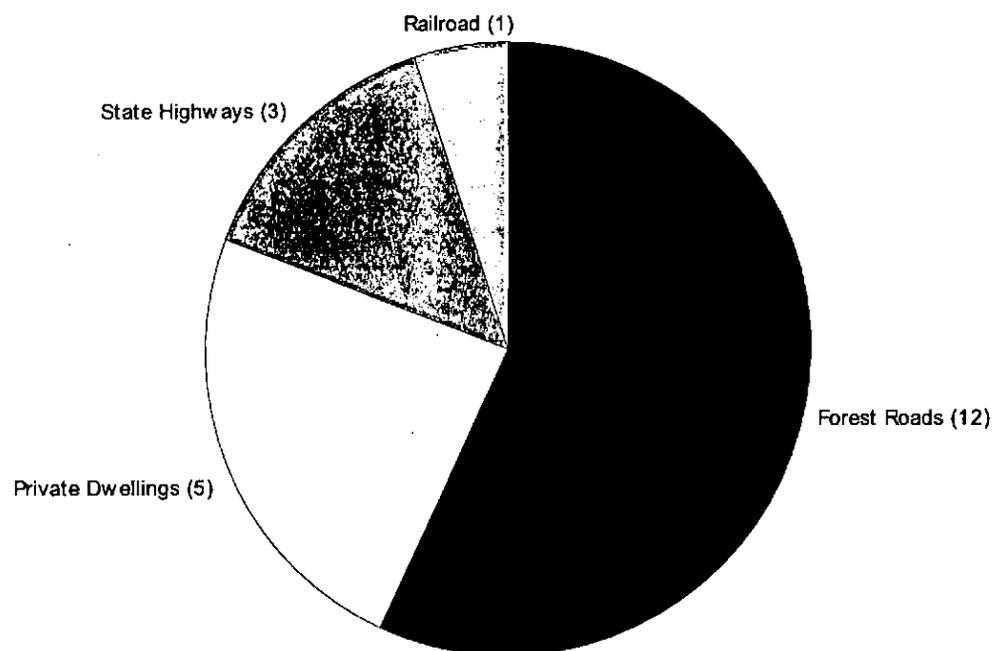
Fig. 3.9 Types and numbers of engineered structures damaged by dam-break floods (n = 20).

Figure 3.9 shows the types and number of engineered structures that were damaged. Twelve forest roads were damaged by nine dam-break floods. In three cases

the floods destroyed more than one road crossing. Three state-maintained highways and one railroad grade were damaged by dam-break floods. At least five private dwellings, all of which were built on alluvial fans, were damaged by these types of floods. In the narrow valleys of the Cascade and Olympic Mountains, most main thoroughfares pass close to the mountain fronts making them susceptible to damaging effects of dam-break flooding.

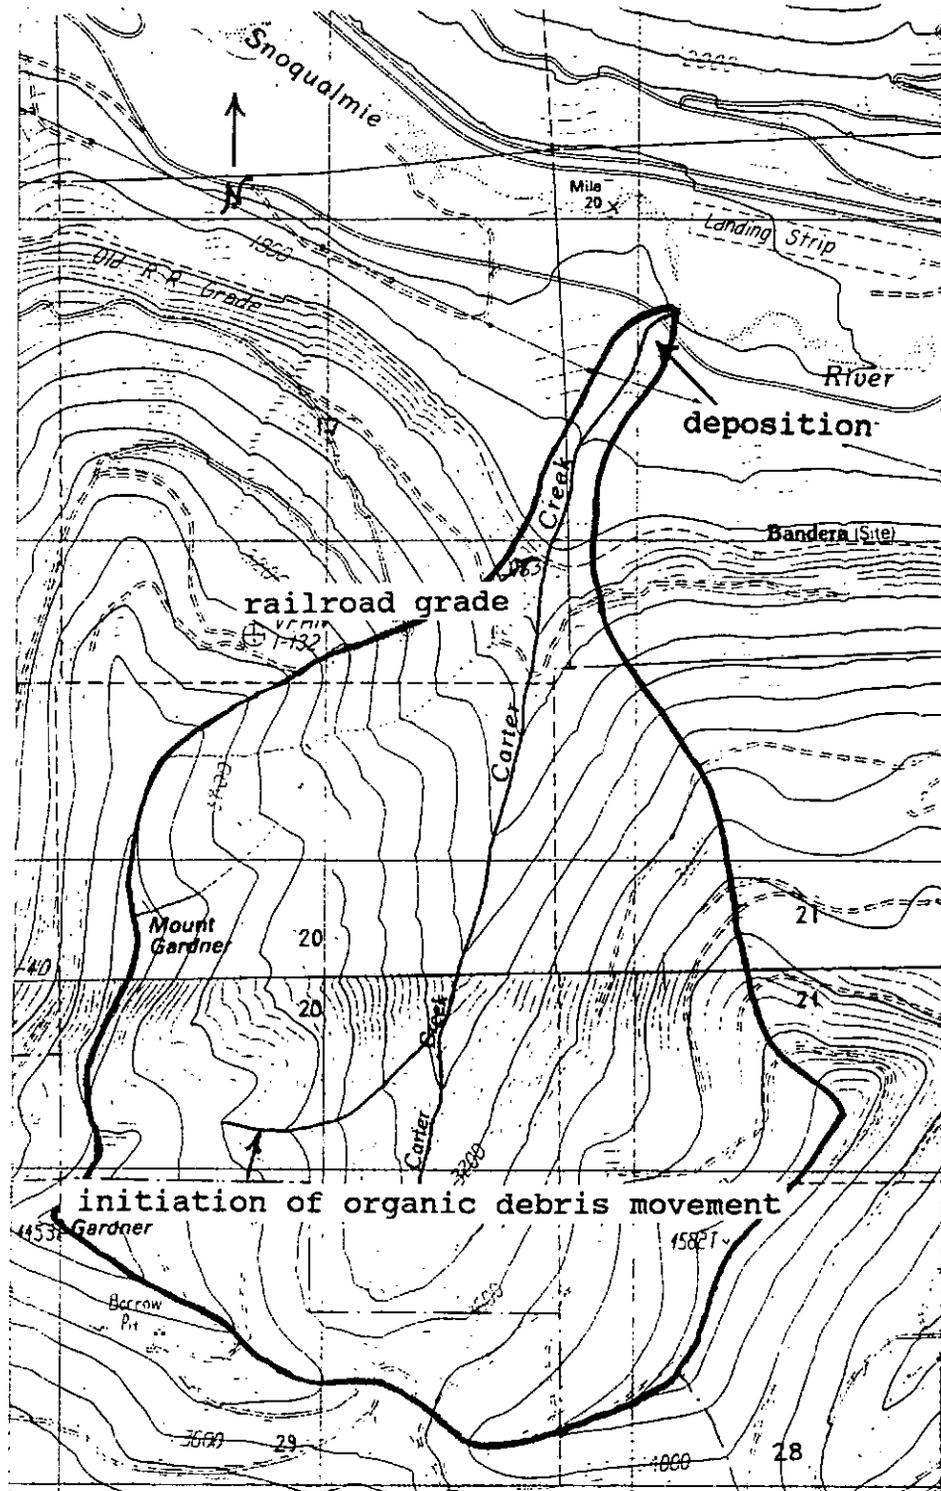
Fig. 4.1 Topographic map of Carter Creek basin (scale 1:24,000, contour interval 40 ft).

Carter Creek experienced a flood of woody debris-laden water between November 21 and November 26, 1990, which caused the removal of two US Forest Service roads and a railroad embankment where they crossed the creek (Figure 4.1). The heavy rain that caused this flooding followed approximately 515 mm of rain in the preceding 3 week period. Two hyetographs from stations flanking Carter Creek are shown in Figure 4.2. (The precipitation station reference numbers are the same as used by Earth Info, suppliers of precipitation data on CD-ROM optical data disks.) The relationships between flood height and estimated volume of impounded water (and debris) at eleven downstream locations are shown in Figure 4.3.

The location of initiation of movement of organic debris within the channel (Figure 4.1) was evident during the first site visit. There was a marked absence of organic debris in the stream valley from this location downstream to the railroad grade, a distance of 2 km. Above the initiation site, the channel was filled with a 1-m thick layer of logging slash and debris, obscuring the channel bed from view. From this initiation point downstream, small piles of organic debris (1 to 3 logs high) were present along the top of the inner gorge. Downstream of the railroad grade, evidence of a large

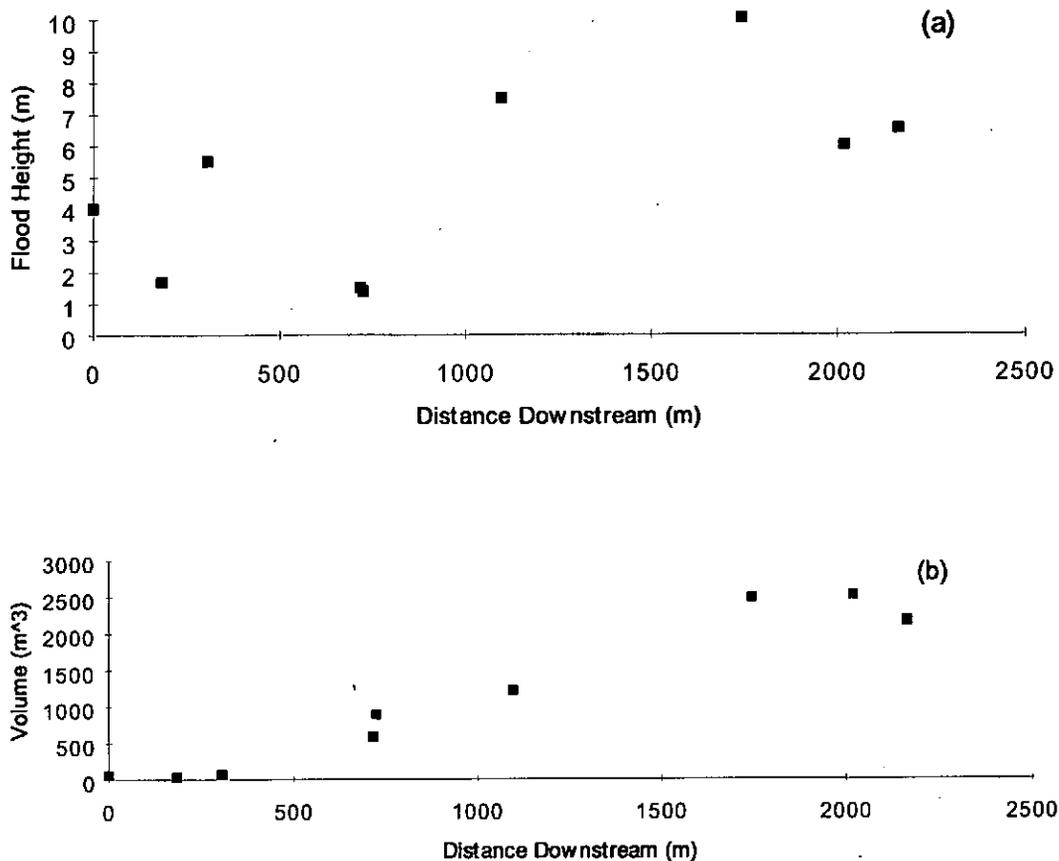
Fig. 4.3 (a) flood height and (b) estimated volume of impounded water on Carter Creek.

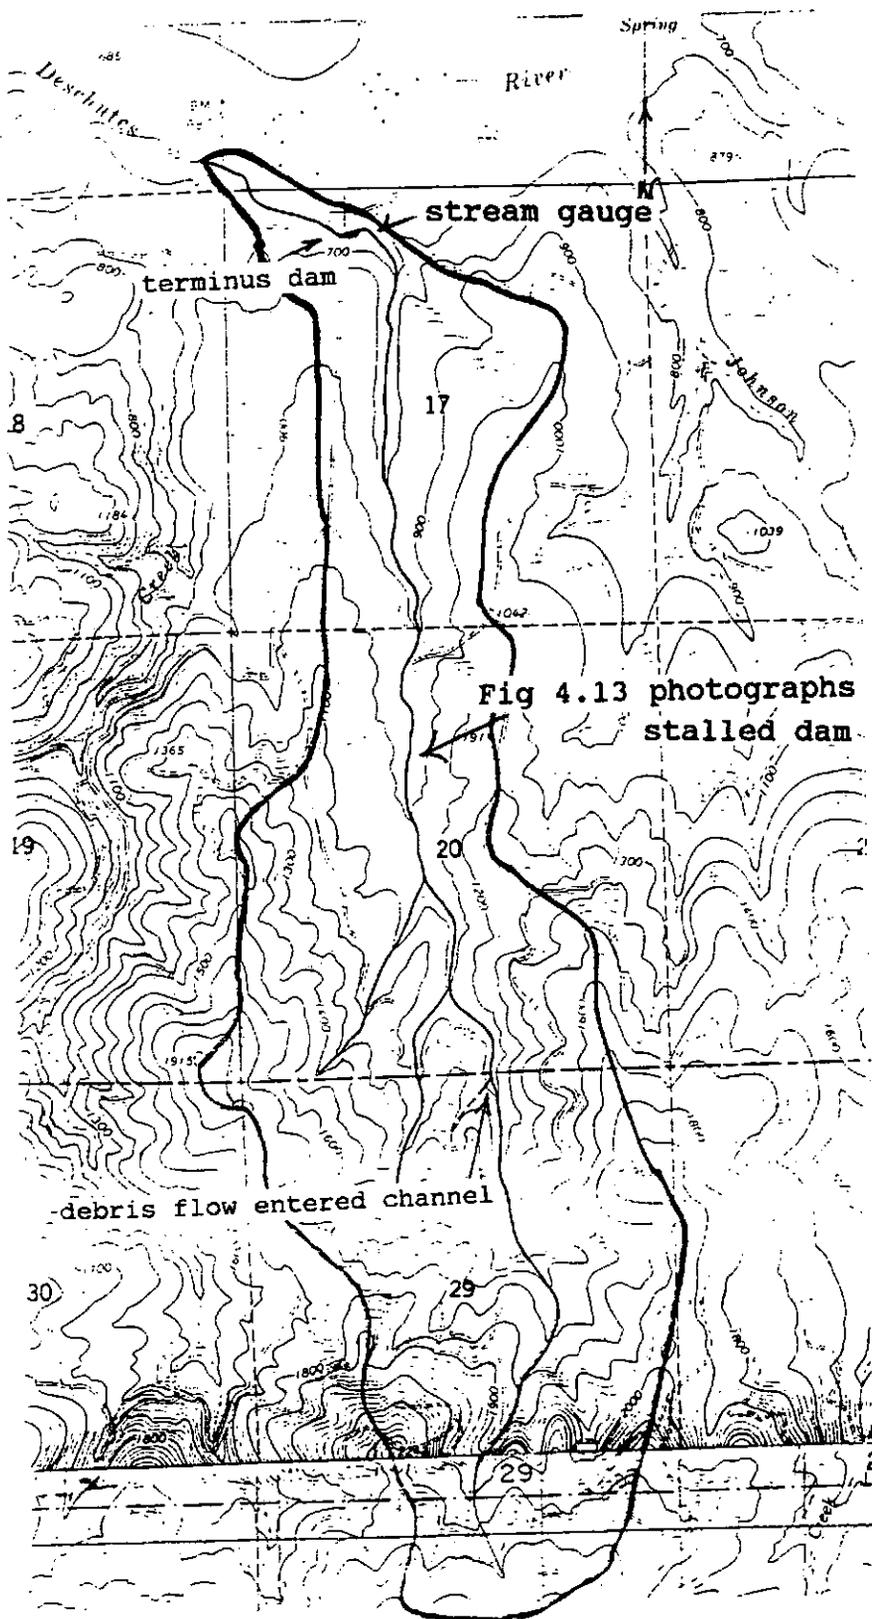
Fig. 4.4 Topographic map of Huckleberry Creek basin (scale 1:24,000, contour interval 20 ft).

A debris flow, resulting from the failure and movement of a portion of a service road, deposited into Huckleberry Creek on January 9, 1990, and caused a temporary dam to form. The location is shown in Figure 4.4. This debris-flow deposited dammed

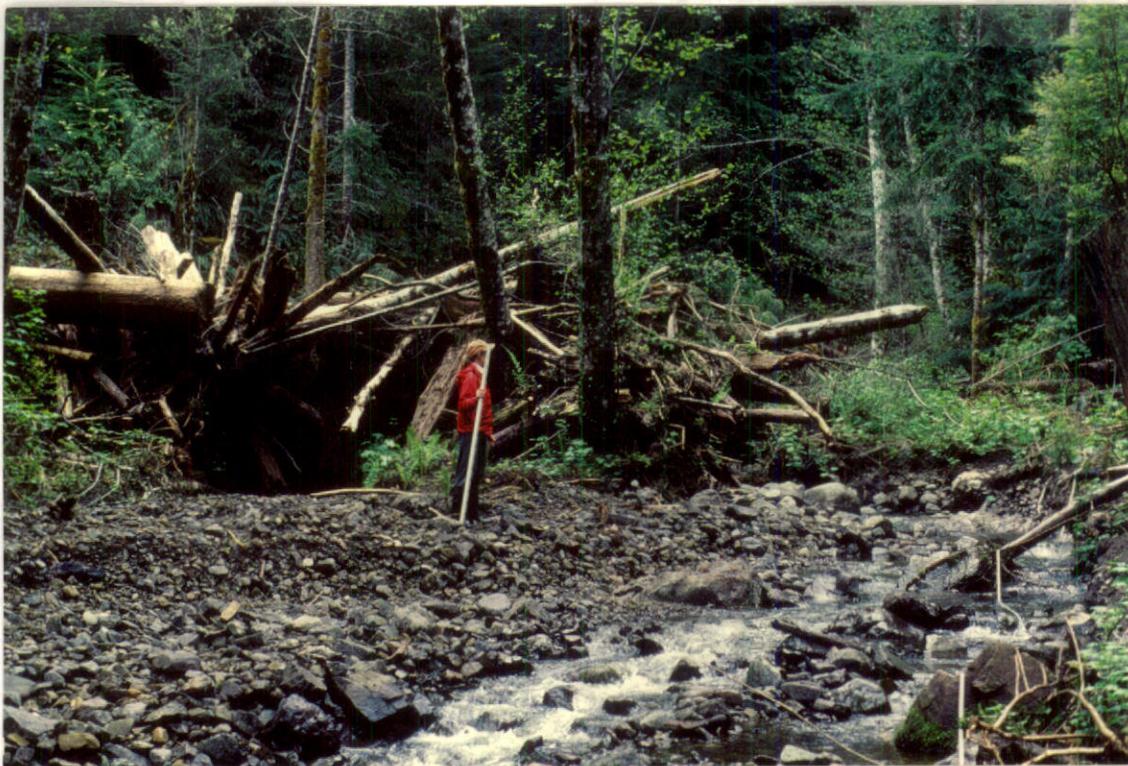
Fig. 4.5 Upstream view of stalled organic dam on Huckleberry Creek (location shown in Figure 4.4, approximate elevation 300 m).

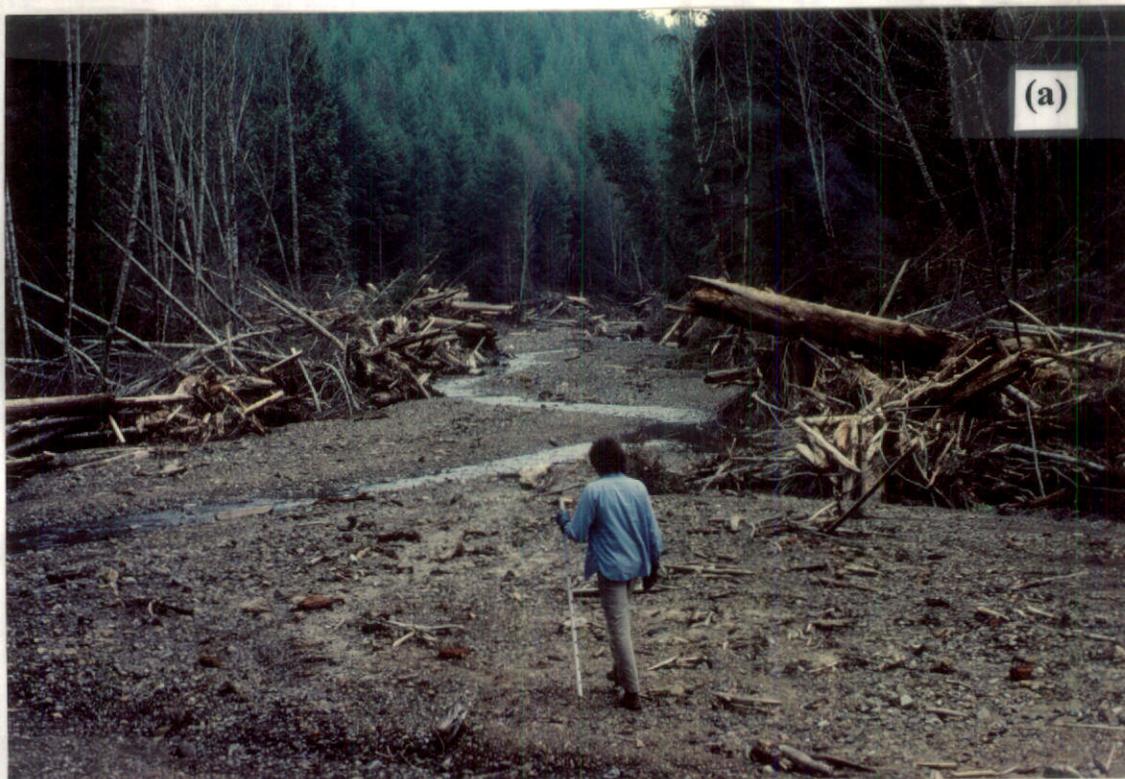
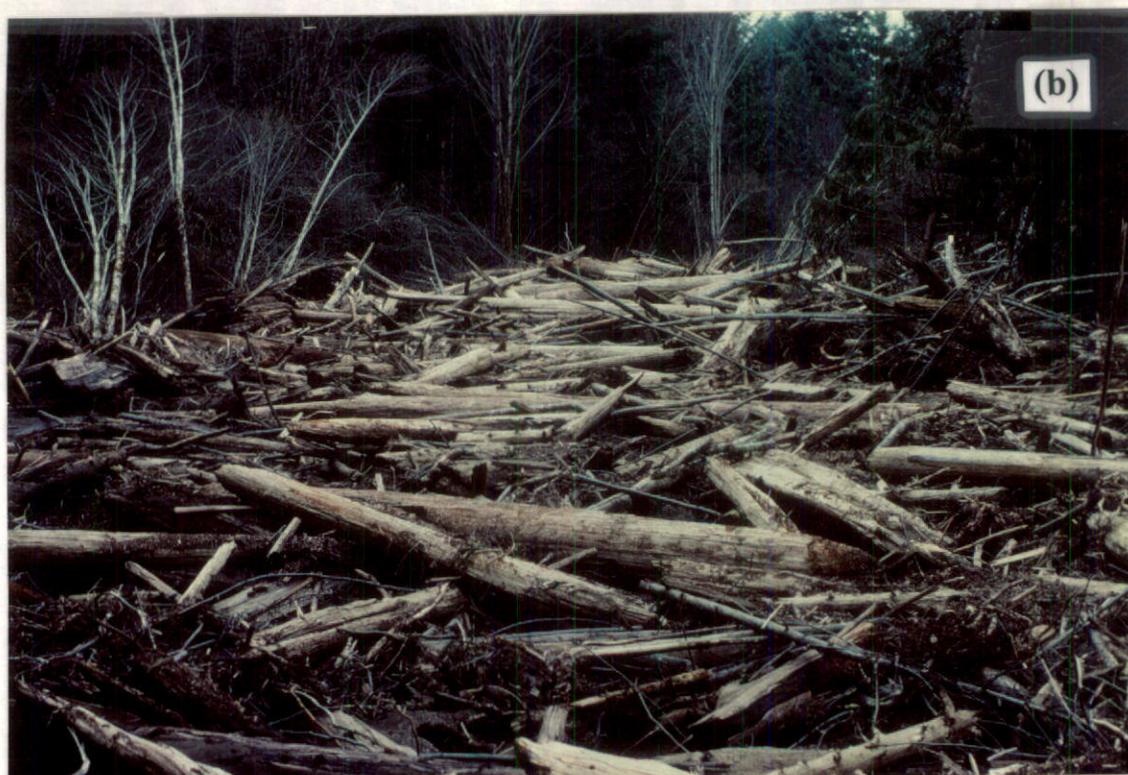
Fig. 4.6 a) Upstream and b) downstream views of Huckleberry Creek immediately upstream of dam terminus (approximate elevation 200m).

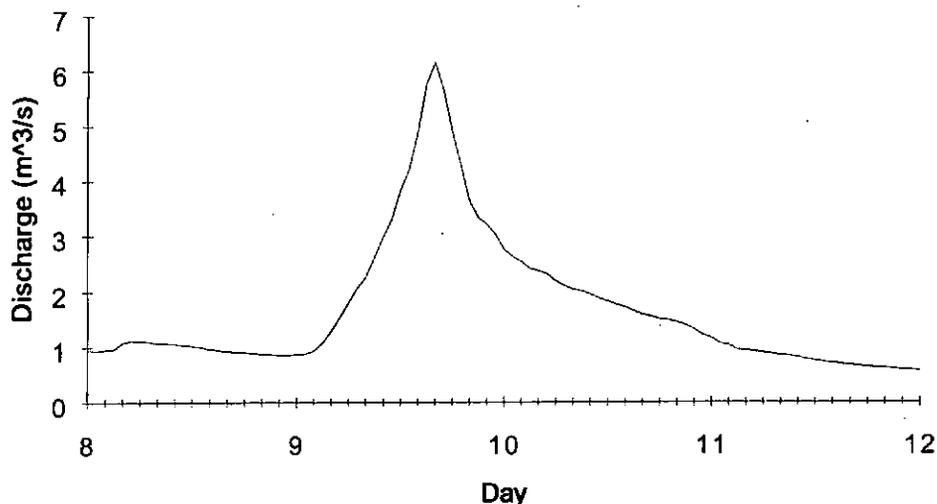
Fig. 4.7 Estimated downstream hydrograph of Huckleberry Creek in the absence of debris-dam failure for January 8-12, 1990; gauge location shown in Figure 4.4.

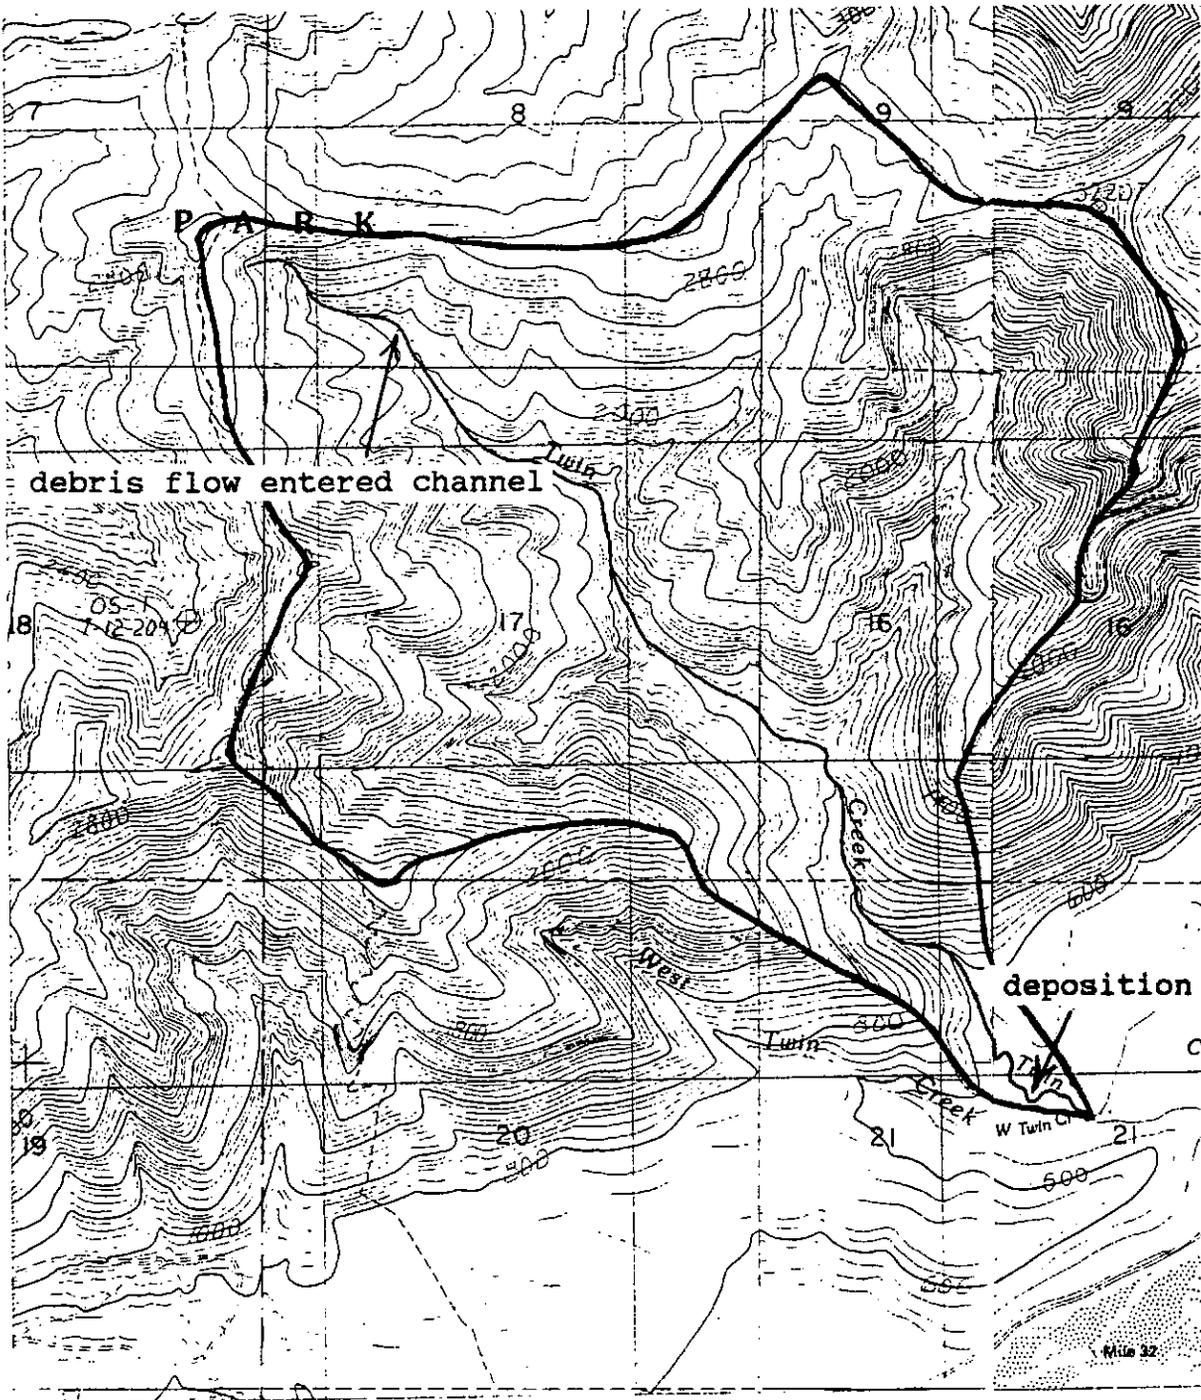
Fig. 4.9 Topographic map of Twin Creek basin (scale 1:24,000, contour interval 40 ft).

A debris flow entered and dammed temporarily the west fork of Twin Creek (Figure 4.9) sometime between November 21 and November 26, 1990. Upon breaching of the debris-flow dam, a flood wave traveled through a bedrock canyon for 200 meters and then through a mature coniferous stream valley. Several piles of organic debris were snagged on the stream valley conifers that were able to withstand the movement of

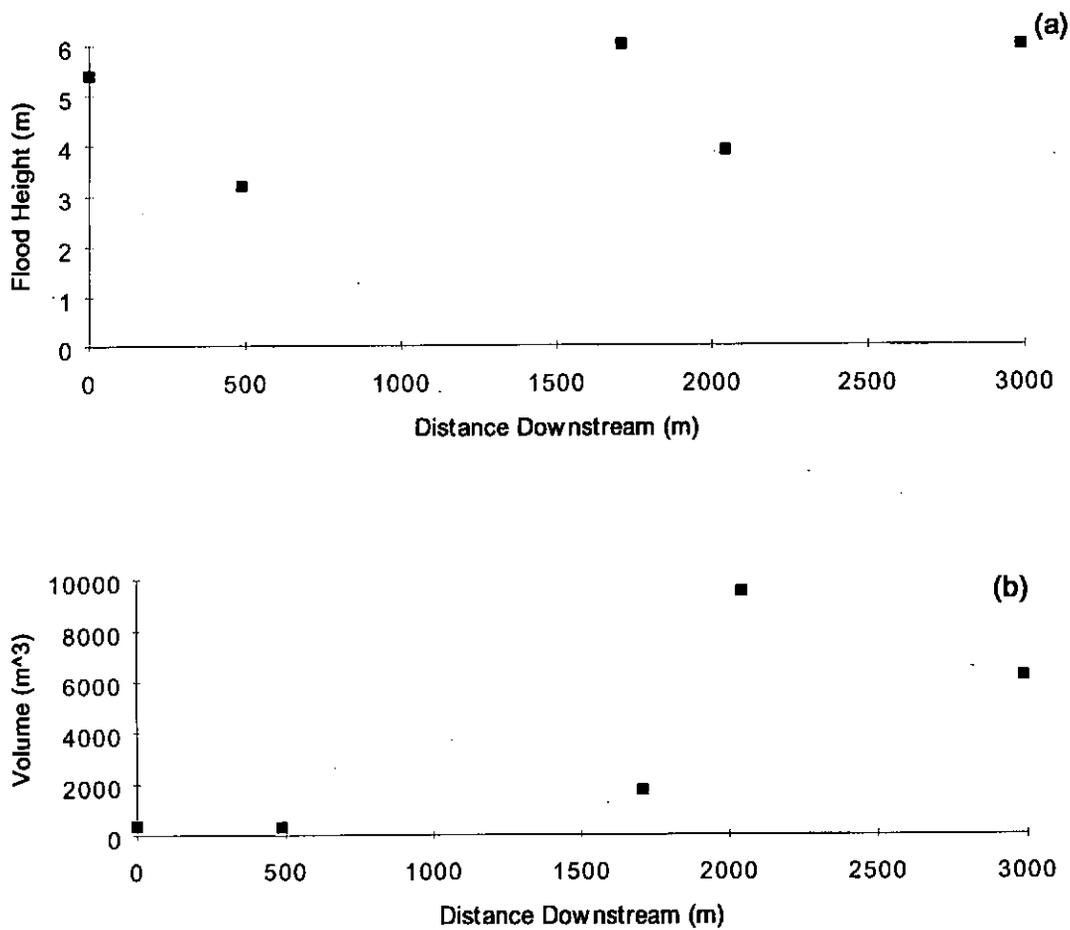
Fig. 4.11 (a) Flood height and (b) estimated volume of impounded water as a function of distance from the initiation site along Twin Creek.

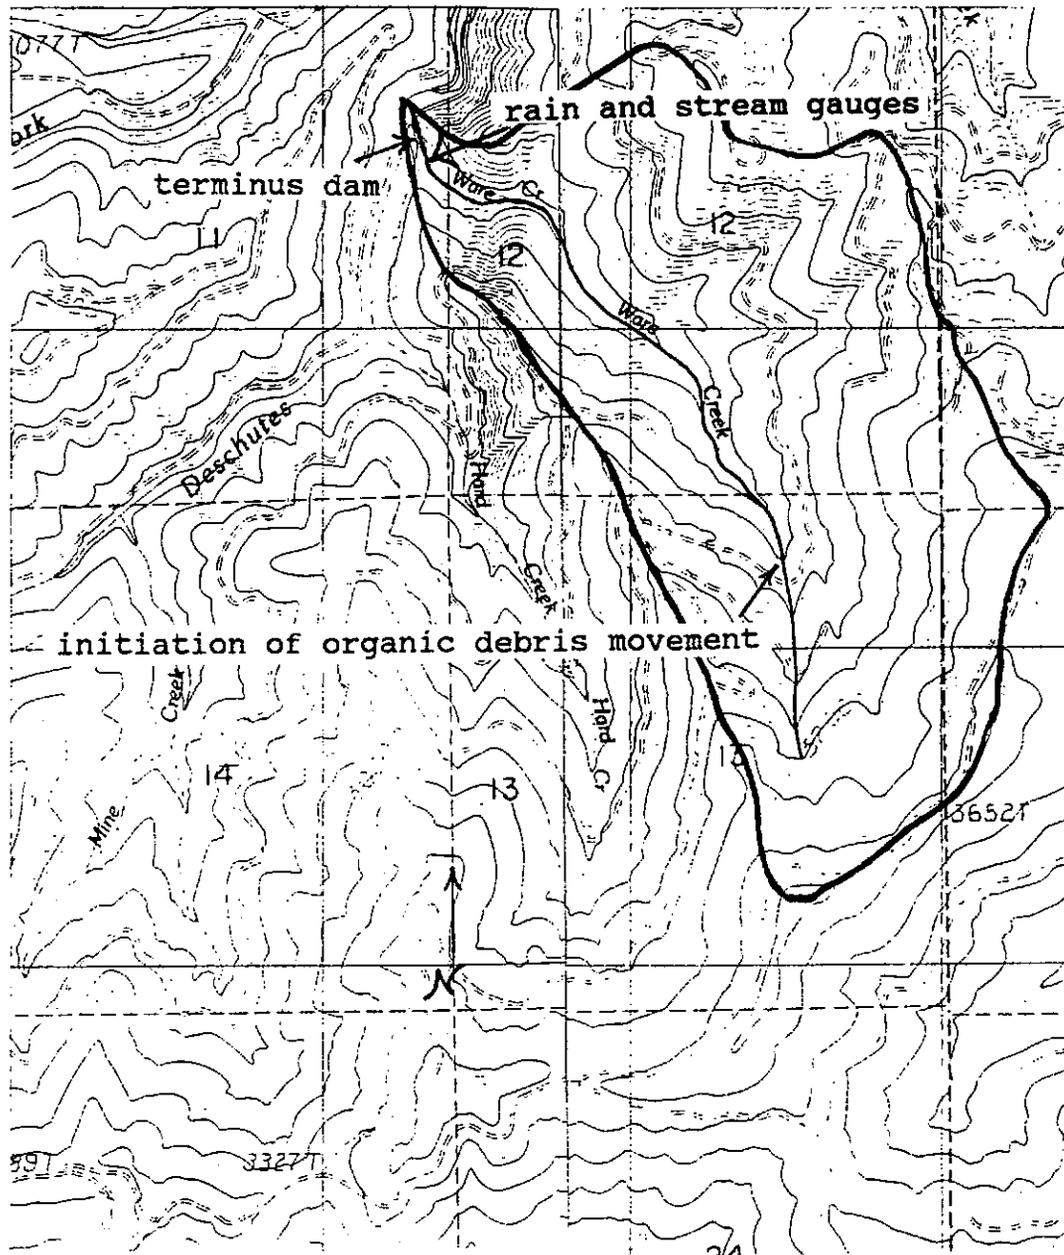
Fig. 4.12 Topographic map of Ware Creek basin (scale 1:24,000, contour interval 40 ft).

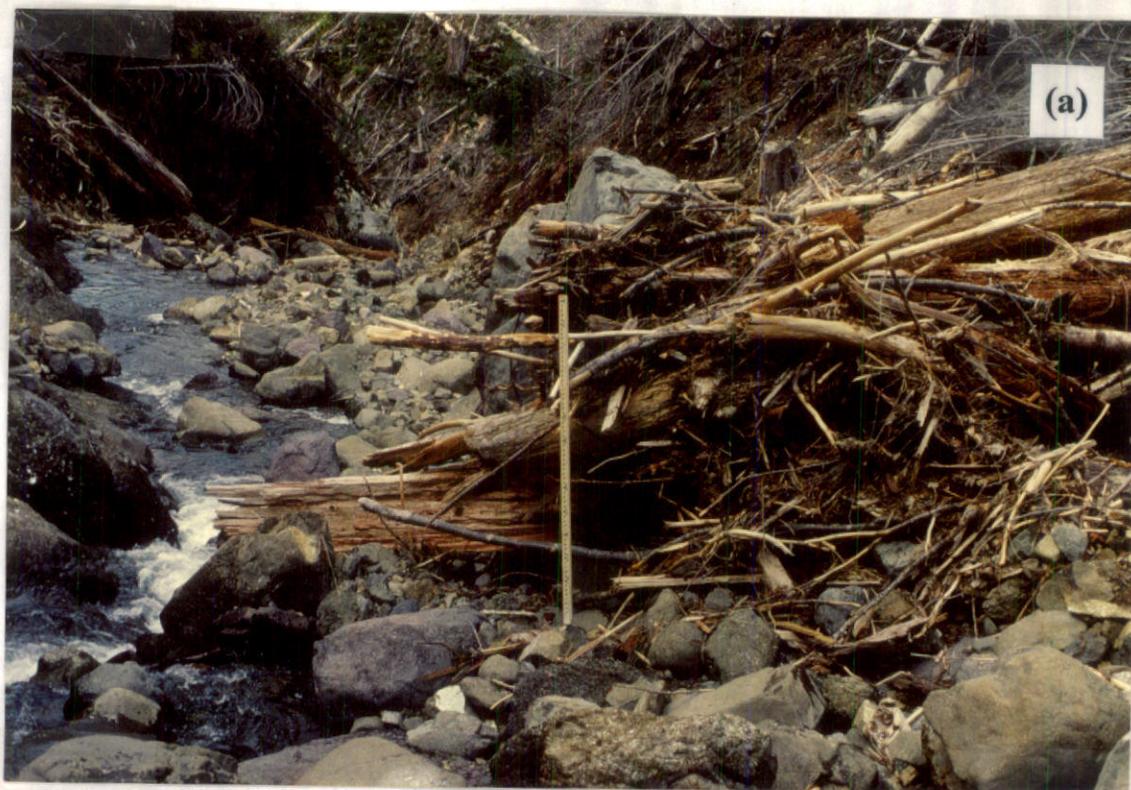
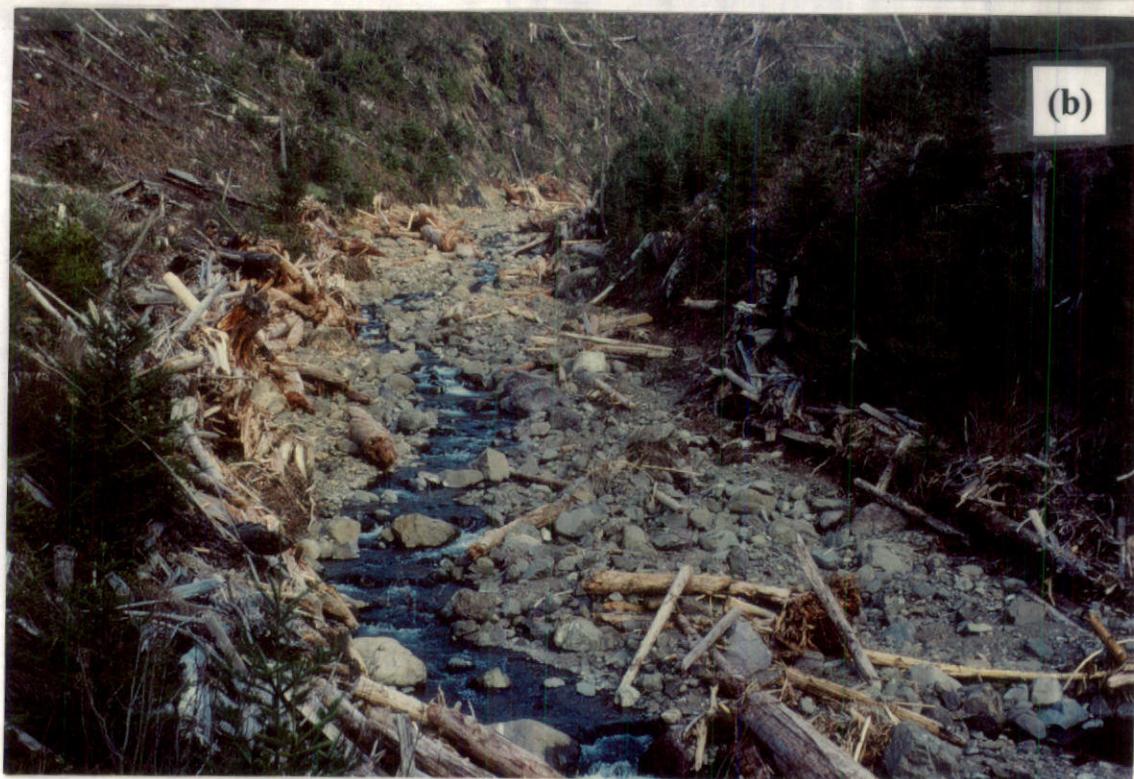
Fig. 4.13 Photographs of debris remnants, Ware Creek: (a) organic dam remnants snagged on a boulder, location 1, Figure 4.12a, and (b) deposition of organic debris along the creek, location 2, Figure 4.12b.

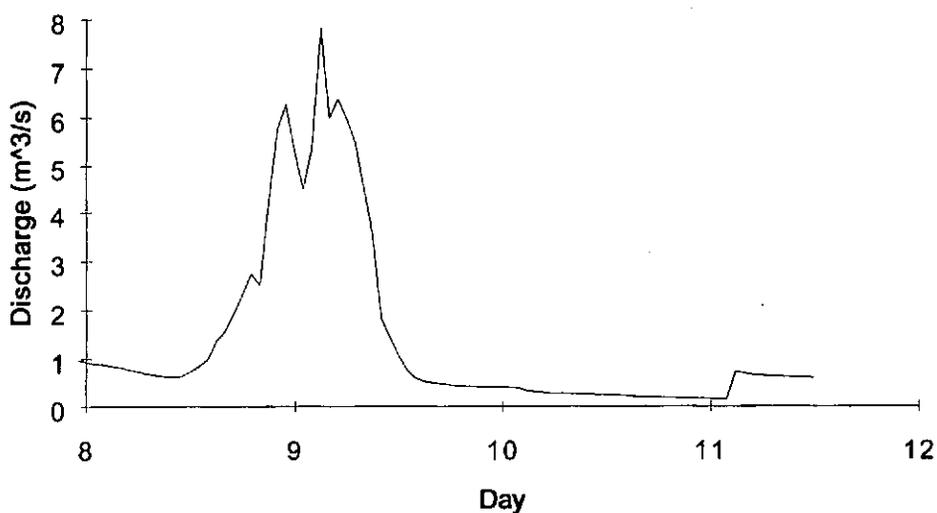
Fig. 4.15 Estimated hydrograph of Ware Creek in the absence of debris dam failure, January 8-12, 1990; gauge location shown in Figure 4.12.
