**DAM-BREAK FLOODS IN  
LOW ORDER MOUNTAIN CHANNELS  
OF THE PACIFIC NORTHWEST**

**Project Completion Report for the Award  
"An Examination of the Forms of Initiation of  
Floods From the Breaching of Non Engineered Dams"  
Administered by the State of Washington  
Department of Natural Resources  
Timber Fish & Wildlife  
TFW-SH9-93-001**

**Water Resources Series  
Technical Report No. 138**

**June 1994**

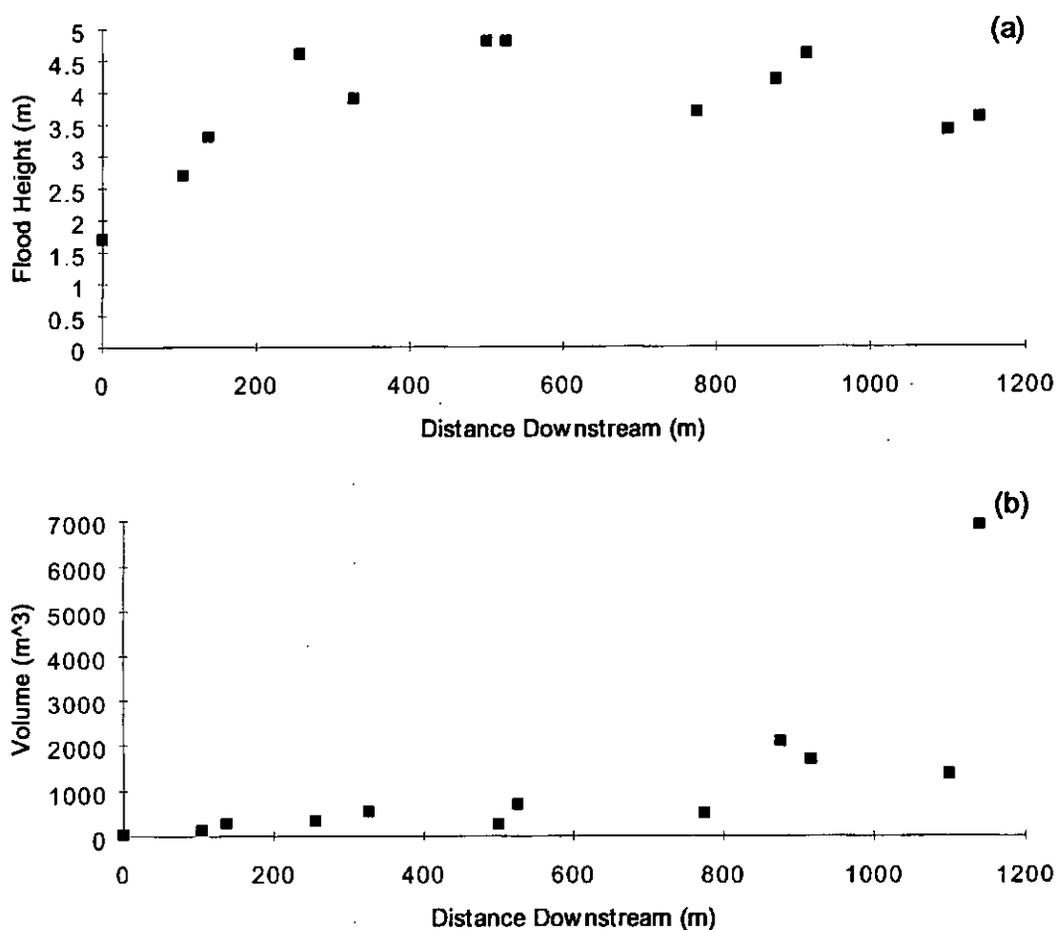
Fig. 4.16 (a) Flood height and (b) estimated volume of impounded water as a function of distance from the initiation site along Ware Creek.

Ware Creek, which is located close to Huckleberry Creek (Figure 1.3), experienced a flood of woody debris-laden water on January 9, 1990, the same day that the dam-break flood occurred on Huckleberry Creek. A plan view of the Ware Creek catchment showing the woody debris initiation location, debris deposit terminus, rain gauge and stream gauge locations, and location of Figure 4.13 is given in Figure 4.12. Mobilization of logging slash and debris within the stream channel occurred without any apparent introduction of material displaced from mass wasting into the stream valley. The moving mass of organic debris traveled 1.5 km downstream where it was stopped by a service road crossing. Photographs of the remnants of a stalled dam and organic debris deposited along the base of the valley walls which define the channel are shown in Figure 4.13. This dam-break flood occurred after 200 mm of precipitation in the preceding 24 hours. The hyetograph is shown in Figure 4.14, and the estimated hydrograph in the absence of a debris flood is shown in Figure 4.15. The data for Figure 4.14 were provided by Weyerhaeuser Corporation (J. Heffner, personal communication, 1993). The estimated hydrograph is based on a regression of Ware Creek flow rate against recorded flow rate in neighboring Hard Creek (J. Heffner, personal communication, 1993). We do not know the time movement began but have included Figures 4.14 and 4.15 for use by others should the initiation time become known. The relationships between flood height and estimated volume of impounded water (and debris) at six downstream locations are shown in Figure 4.16.

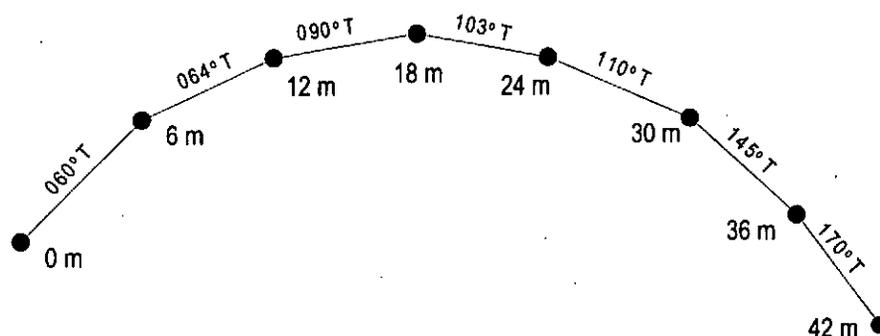
Fig. 5.1 Plan view of bend on Carter Creek and recorded true compass bearings (location shown in Fig. 4.1)

is approximately normal. These expressions of joint uncertainty suggest that for Carter Creek, where the measurements were taken, the velocity was about 3.8 meters/sec with a standard deviation of about 0.2 to 0.4 meters/sec.

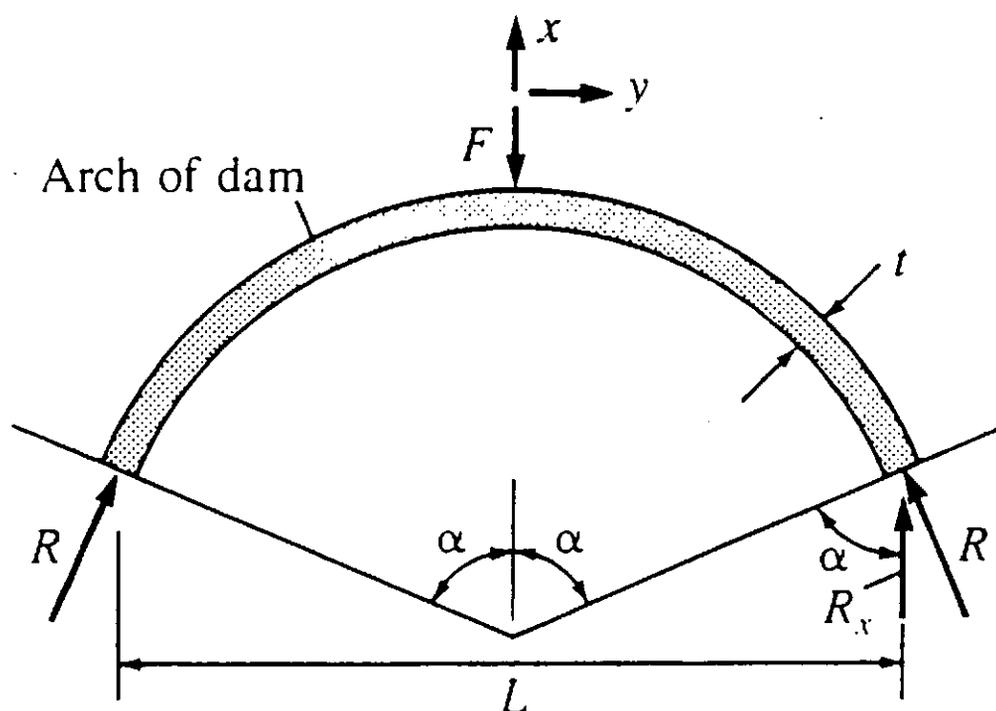
Fig. 5.2 Plan view of arch dam showing applied hydrostatic force  $F$  and the resulting force  $R$  from each abutment transmitted to the arch structure.

The fundamentals of engineered dam theory are applicable to organic debris-dam analysis. Arch dams transfer hydrostatic forces to the canyon walls in which the dam is built. Because arch dams are made usually of concrete, or a composite, the arch shape, as seen in plan view in Figure 5.2, is necessary to withstand the hydrostatic forces of the impounded water. The net hydrostatic force  $F$  is resisted by abutments with  $F = 2R_x$ ;  $R_x$  is the component of  $R$  in the  $x$  direction, and  $R$  is the resultant force at each abutment that is transmitted to the arch structure shown. The organic dams of interest here are assumed to exhibit some characteristics of arch dams. Because organic dams are composed mainly of buoyant organic material elements with specific gravities of around 0.4, the individual

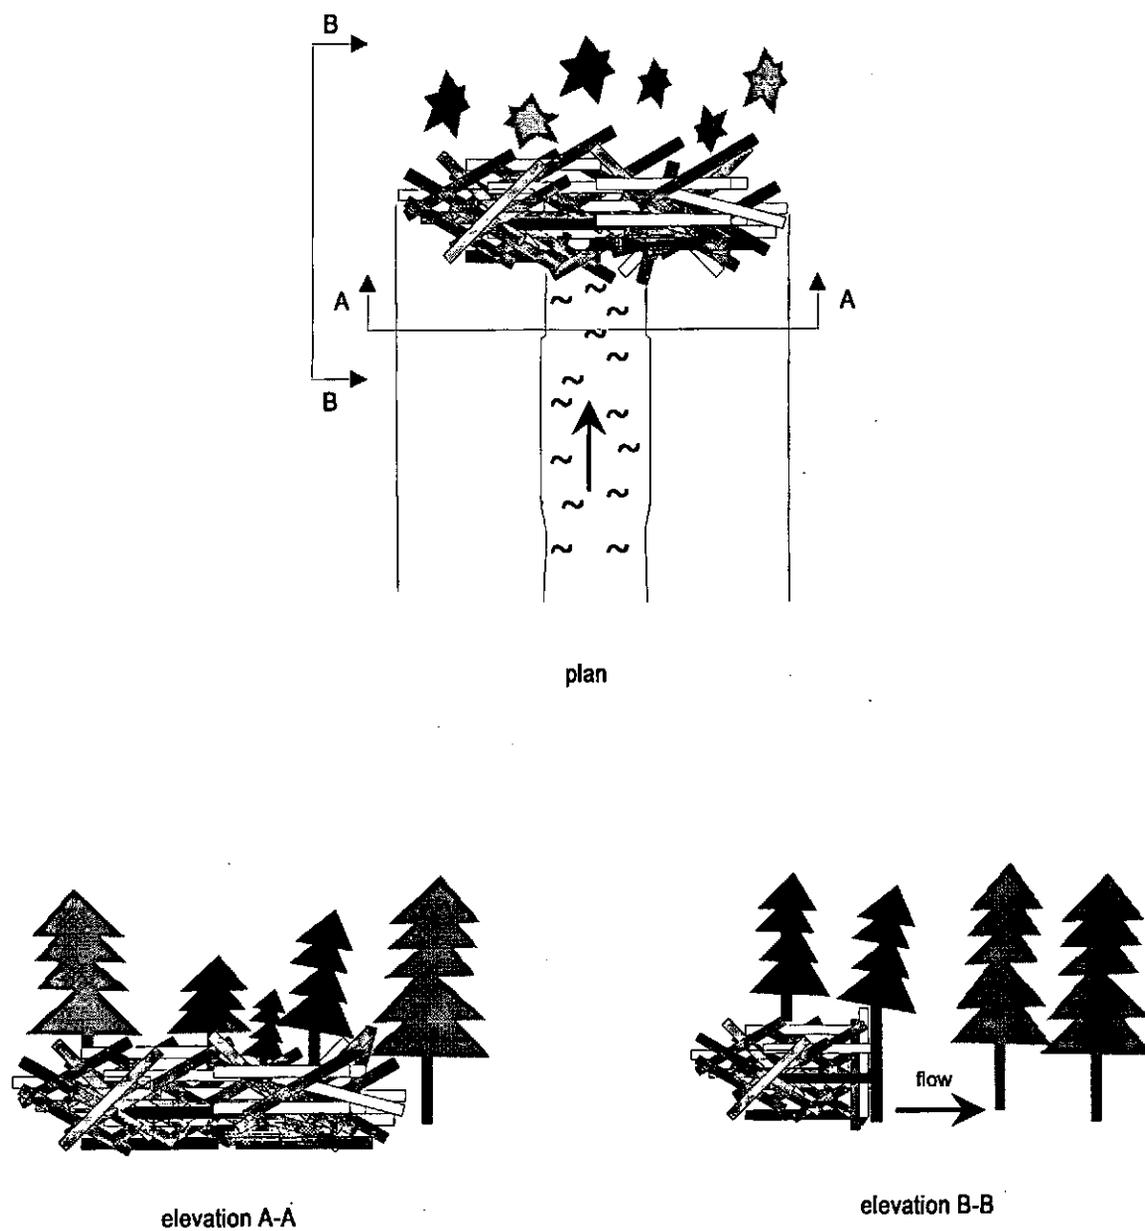
Fig. 5.3 Schematics of the plan, front elevation, and side sectional view of an organic debris dam.

elements are incapable of withstanding hydrostatic and uplift forces, so they are subject to movement. However, in the presence of valley obstructions, such as bedrock controls and riparian vegetation, these dams become snagged (stationary) and transfer their load to valley obstructions, in a similar manner that the arch dam transfers its load to the canyon walls. Organic dams are highly deformable, and composed of intertwined rigid members. Therefore, in plan view, the dam shape is controlled by valley obstructions. A schematic diagram of likely arrangements is shown in Figure 5.3. Structural controls of the stream valley such as canyon constrictions and outcrops are assumed capable of withstanding organic dam forces. Riparian vegetation, consisting of small diameter conifers and broad leaf species in the four catchments described in Chapter 4, was observed to be unable to withstand the dam forces.

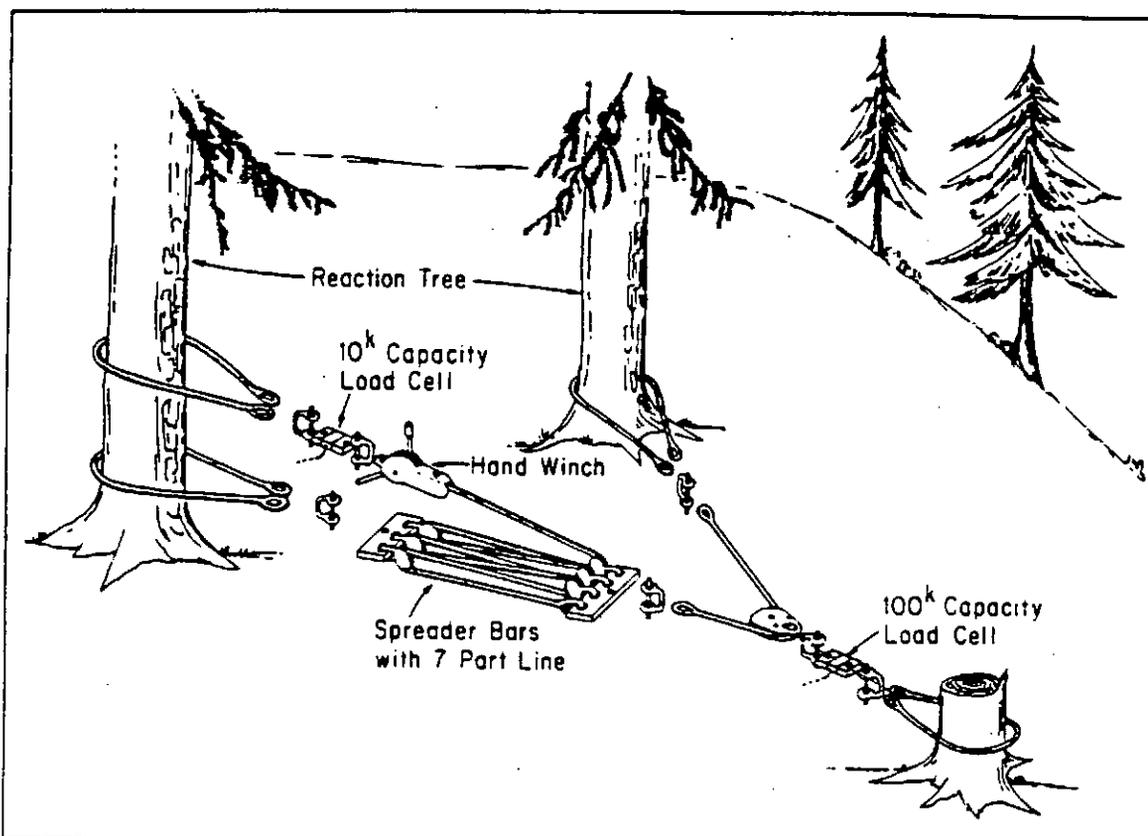
Fig. 5.4 Schematic diagram of Pyles' experiment in which ultimate static loads on tree stumps were measured (load applied 1 ft. above ground surface).

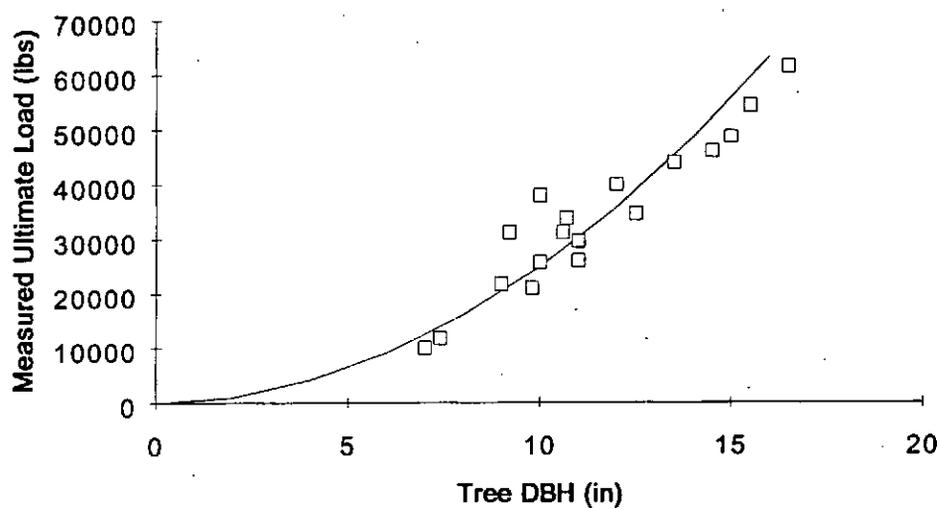
Fig. 5.5 Relationship between ultimate load and tree diameter breast height (DBH).

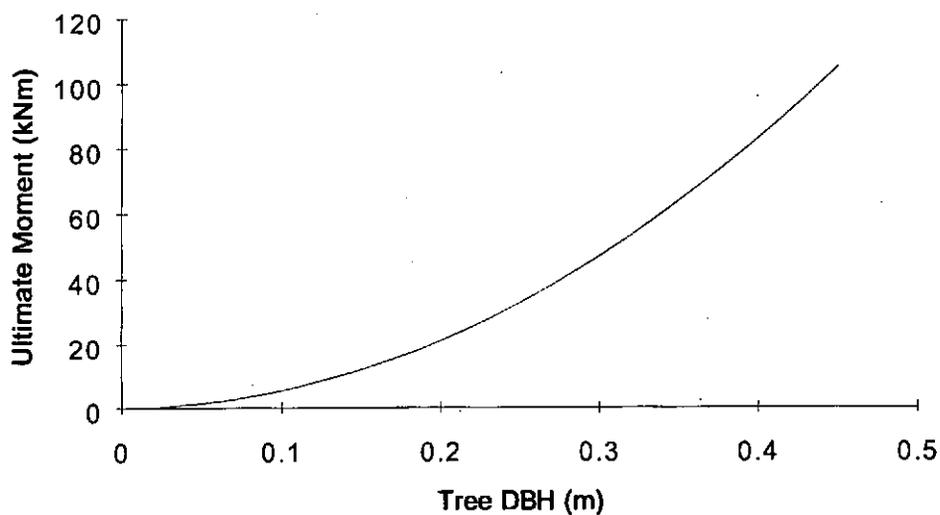
Fig. 5.6 Relationship between ultimate breaking moment and tree diameter breast height (DBH).

We used Pyles' relationship between tree diameter and ultimate breaking strength and related it to estimated moments that would be exerted by the organic dams. For instance, for an applied moment of 3000 kNm, the maximum moment exerted by organic dams in all four streams within the first 1000 meters of travel, a cross-valley row of 30 trees of 0.45 meters

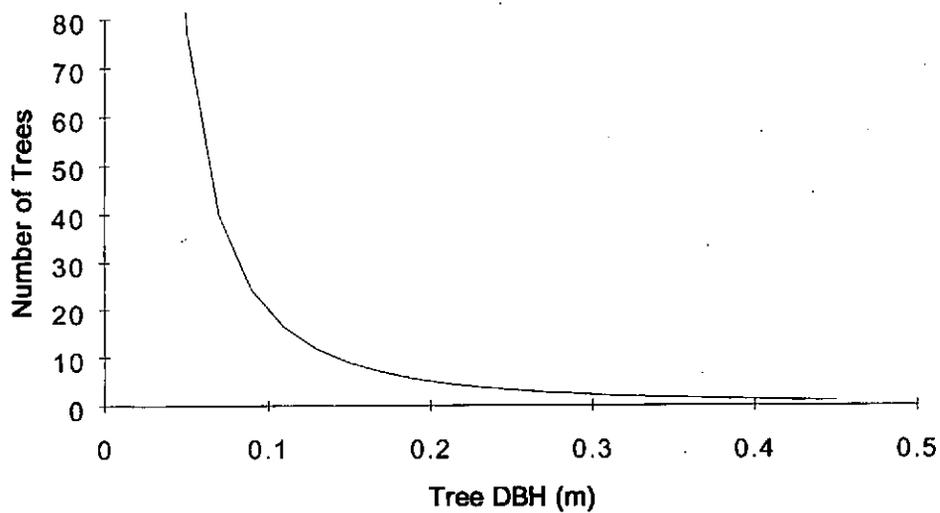
Fig. 5.7 Number of trees necessary for ultimate load to equal that of 1 tree 0.45 meters diameter breast height (DBH).

We transformed the graph of ultimate moment versus tree diameter to show how many trees of a given smaller diameter would be needed to resist the ultimate moment of the 0.45 meters diameter tree, the largest diameter used in Figure 5.6. This relationship is given in Figure 5.7, which shows that ten 0.15-meter DBH, or 25 0.10- meter DBH trees would resist the same ultimate load or ultimate moment. These data and the moments estimated in Tables 5.1 - 5.4 suggest that a few large diameter trees located in riparian zones should be able to withstand moments that would be applied by temporarily stalled organic debris as a

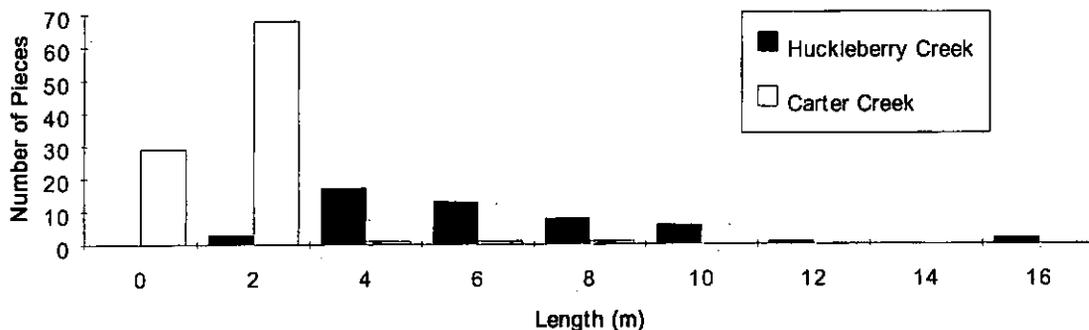
Fig. 5.8 Frequency distributions of lengths of wood in organic debris dams at the initiation site on Carter Creek, and the dam terminus on Huckleberry Creek.

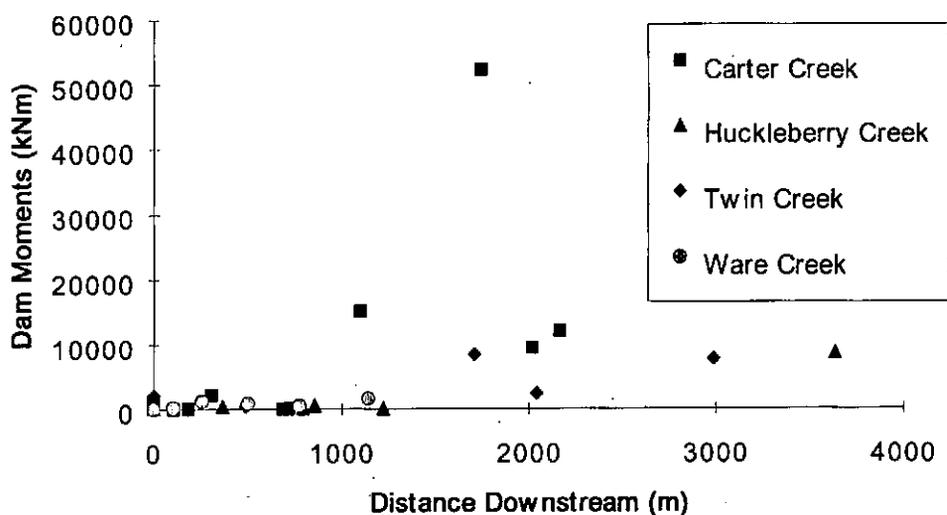
Fig. 5.9 Calculated dam moments as a function of distance downstream from the initiation point.

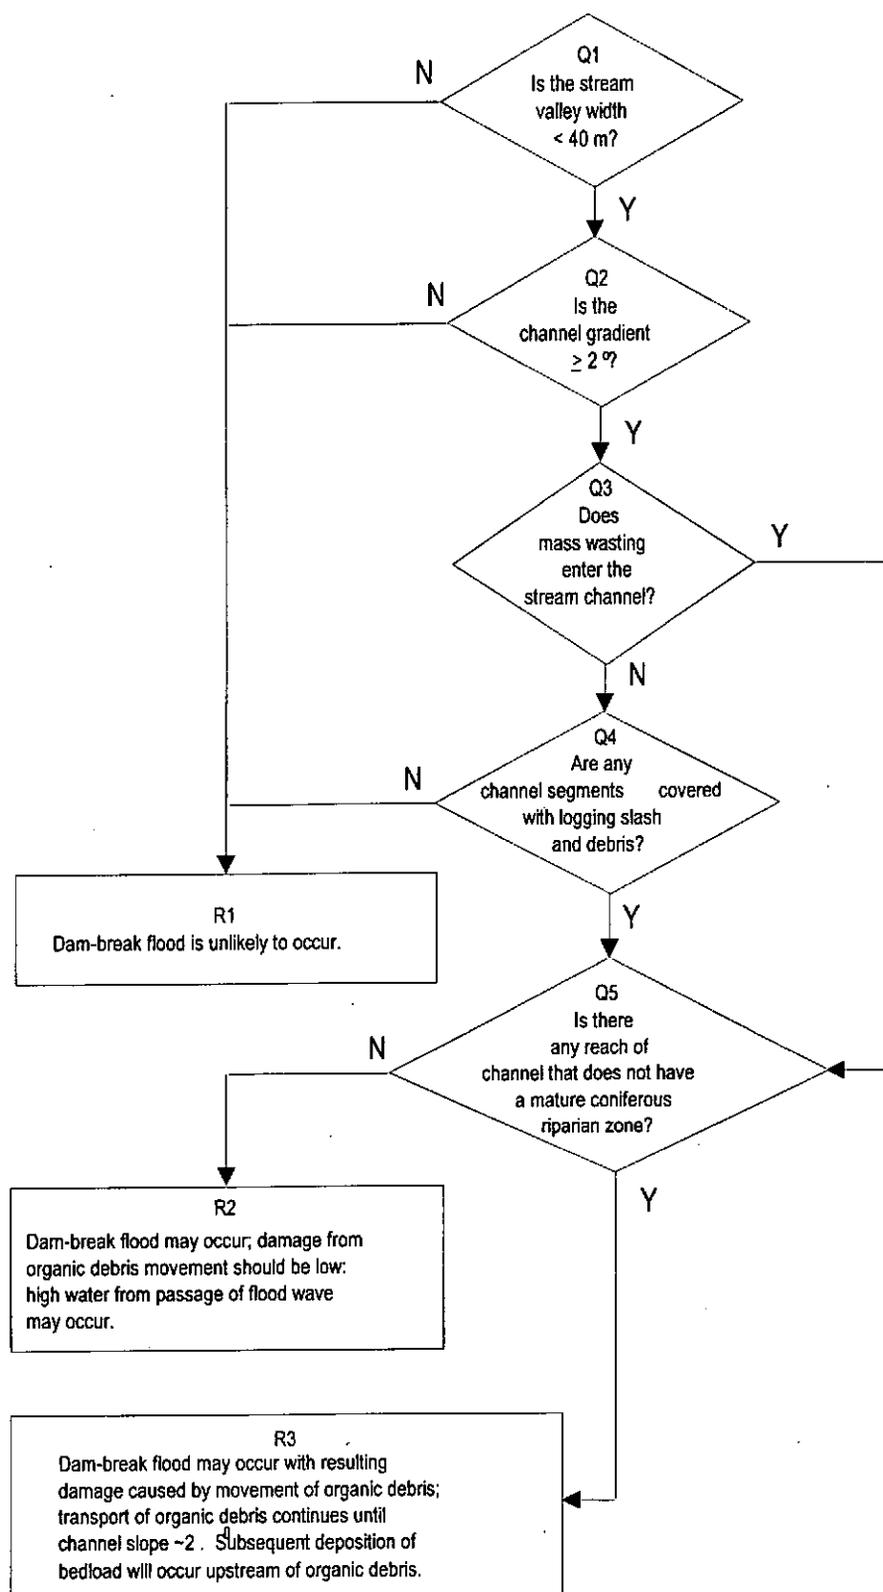
Fig 6.1 Questions for determining potential for dam-break flood damage in mountain streams in the Pacific Northwest.

We do not provide any guidance for managerial decisions. Our simple non-quantitative method makes clear which channel reaches and what lengths of channels are susceptible to organic dam-break floods. Any stream for which the answers to the questions
