**A ROAD DAMAGE INVENTORY  
FOR  
THE UPPER DESCHUTES RIVER BASIN**

By  
Steven Toth

JANUARY 1991

A Final Report  
Submitted to the SHAMW Committee.  
by  
Steven Toth  
January, 1991

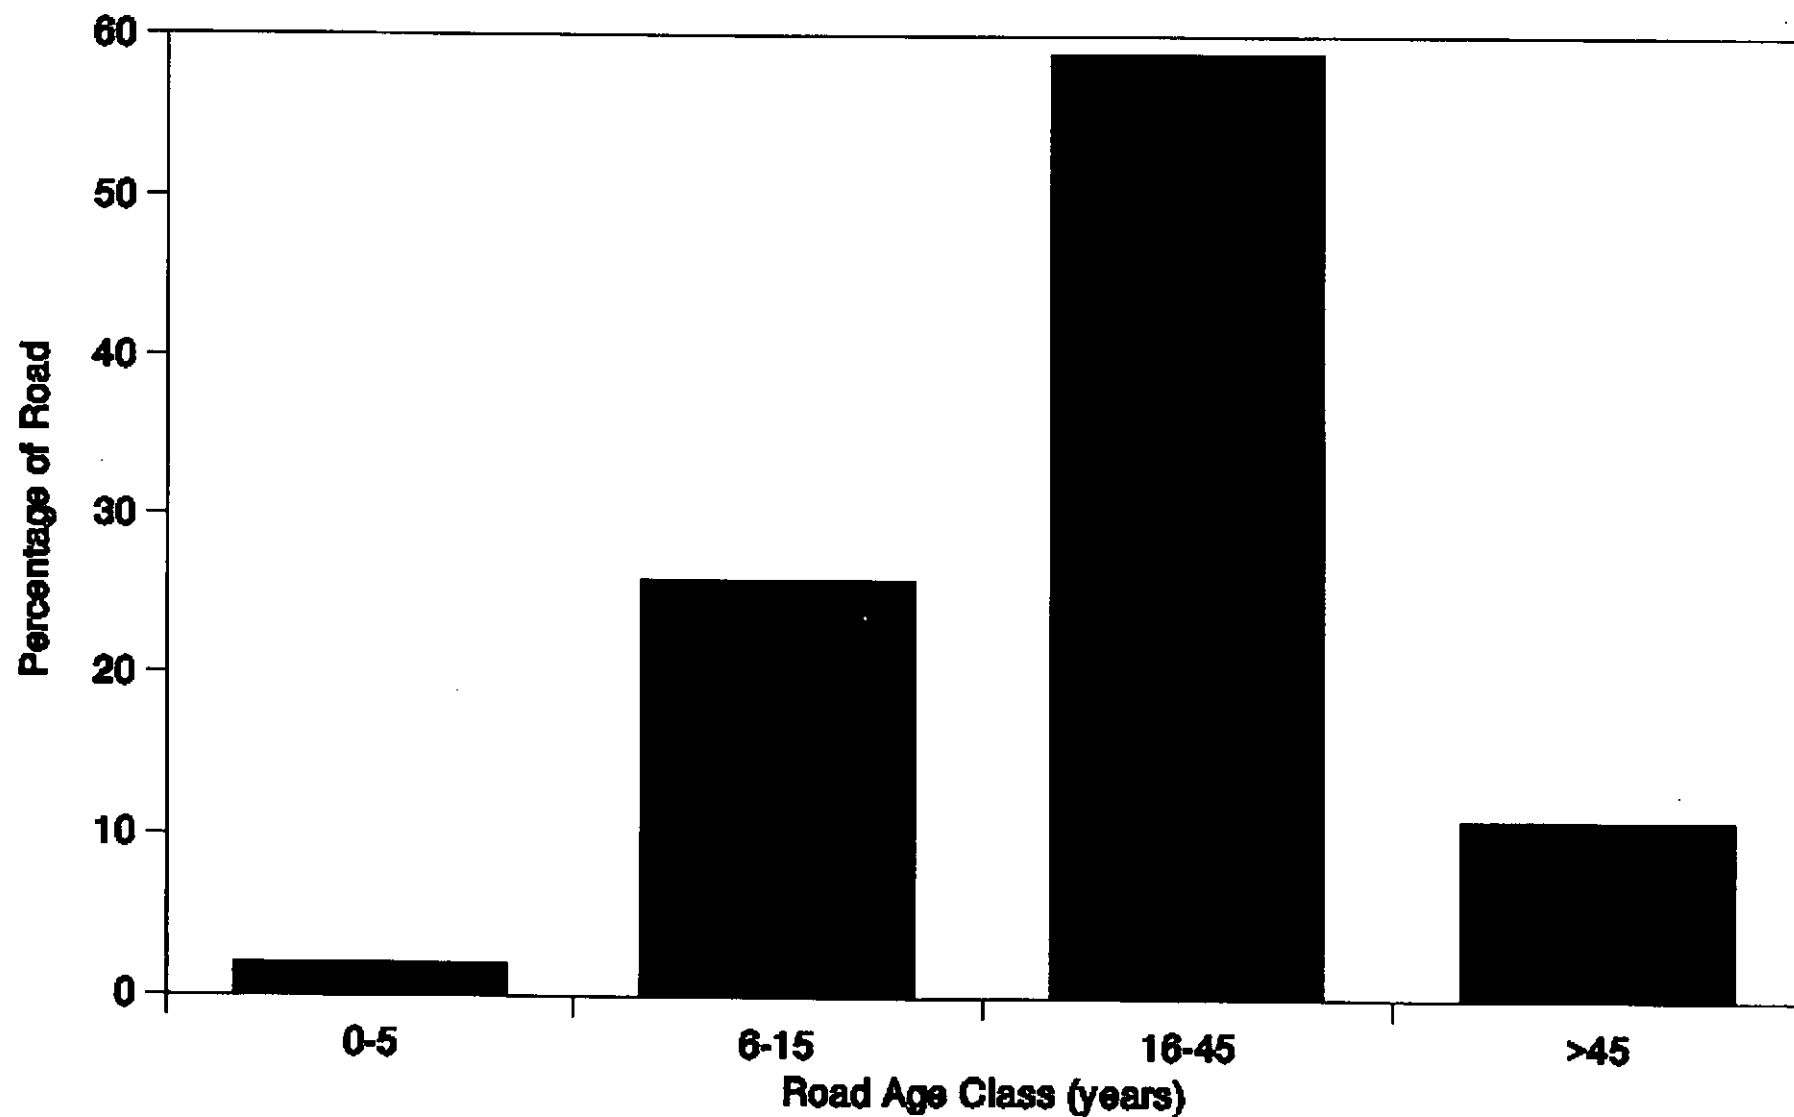
**Figure 7. Proportion of Roads in Basin  
By Road Age Category**

Figure 6 contains the road age map and figure 7 shows the proportion of roads in the basin by age class. The age classes were defined according to changes in construction standards. The oldest roads, 46-65 years old, were built upon old railroad grades, and had large amounts of fill with cedar puncheon culverts at stream crossings. Cedar puncheon culverts consist of two large cedar logs placed parallel along the stream channel with shorter pieces spiked or cabled crosswise on top of the logs (see figure 8). The roads generally had poor surface water drainage with few, if any, relief culverts. These roads are further classified into abandoned, partially-reconstructed, and fully-reconstructed roads. Abandoned roads were not considered because they were inaccessible. Partially-reconstructed roads have had some improvements made to allow for heavy truck traffic and for additional placement of relief culverts. Fully-reconstructed roads have had puncheon culverts replaced with steel ones, new fill material, and a better drainage network installed.

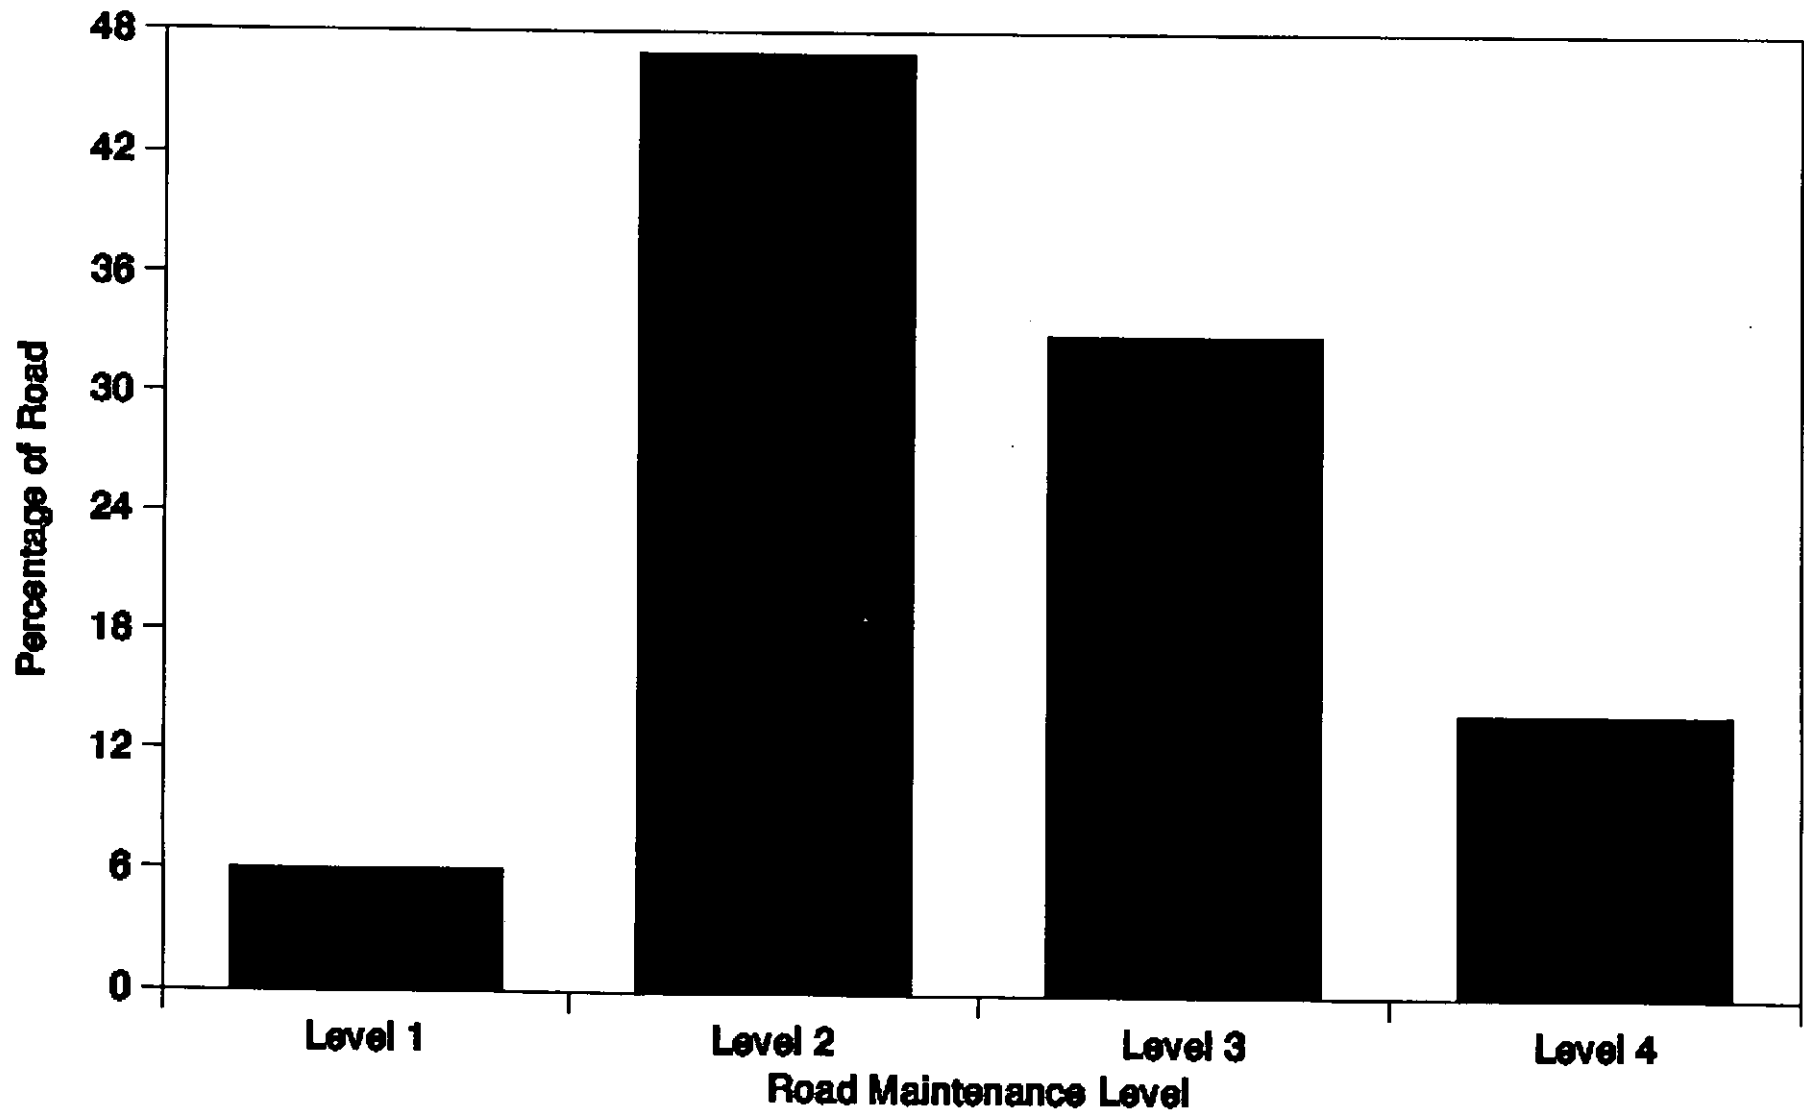
**Figure 11. Proportion of Roads in Basin  
By Road Maintenance Level**

In figure 10, the road maintenance level map divides roads into four categories, and in figure 11 the proportion of roads in the watershed by maintenance level is shown. Level 1 roads are closed roads that have been water barred, but have no drainage maintenance, grading or repairs. They may be inspected after major

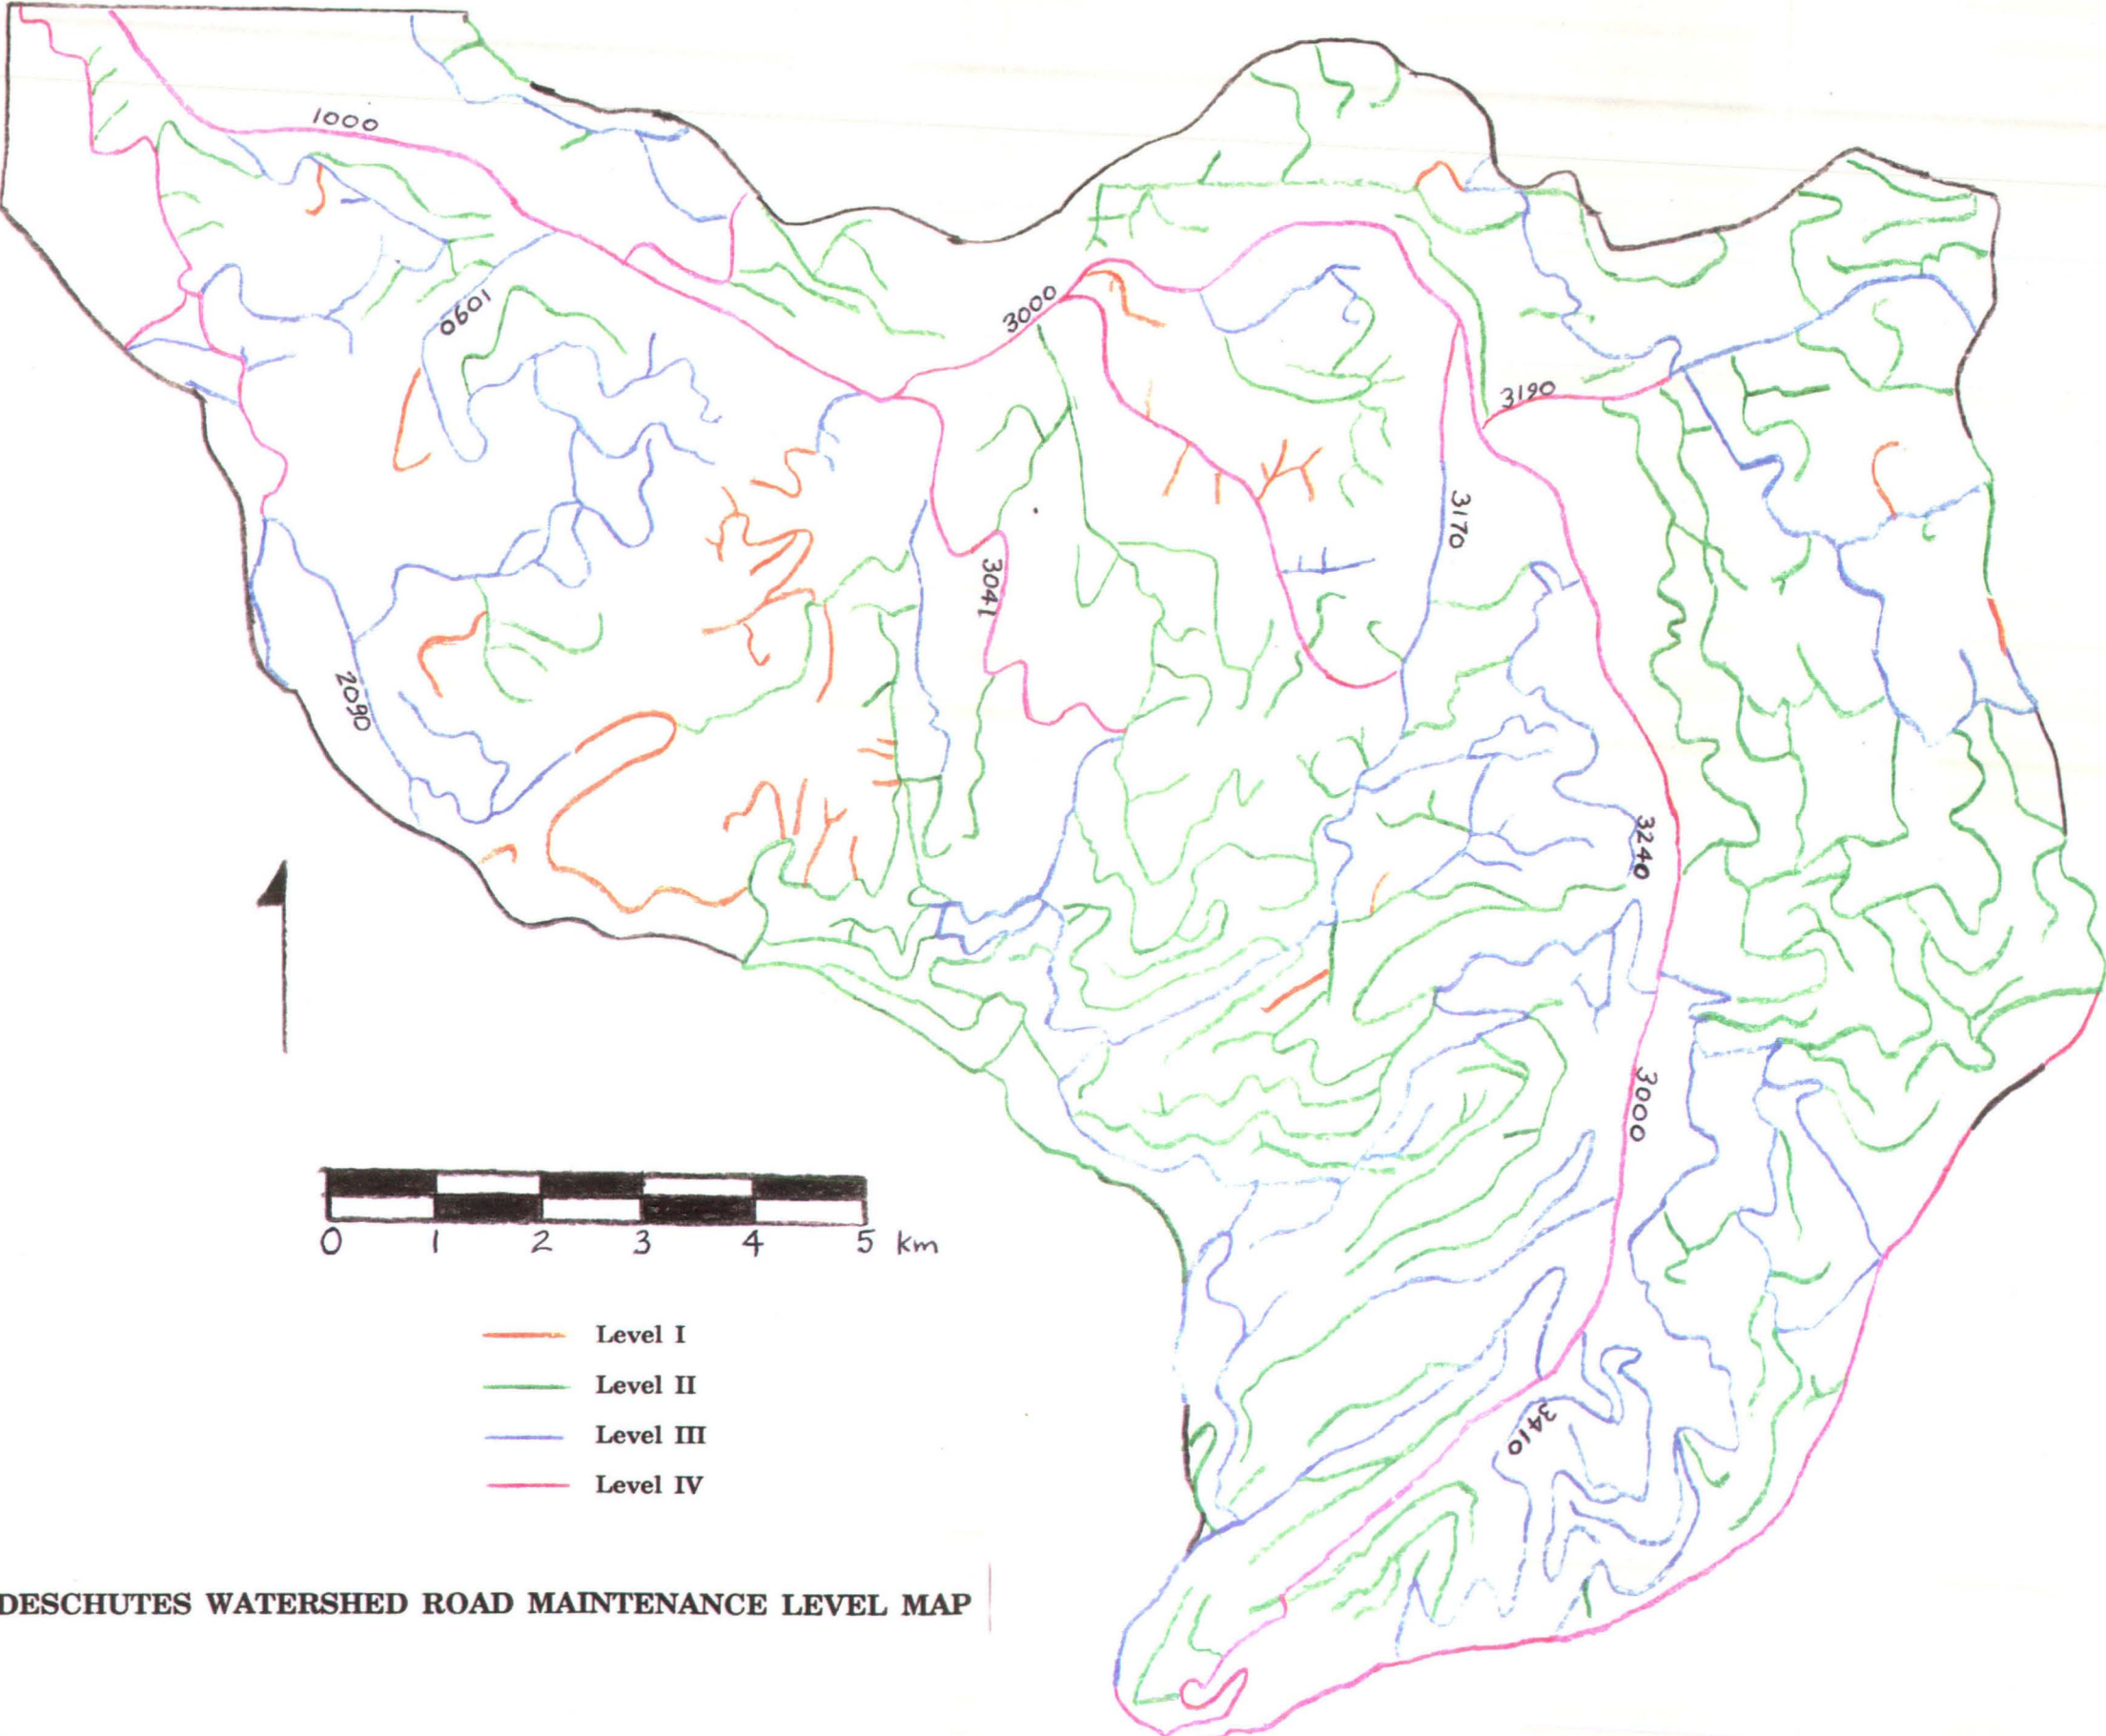
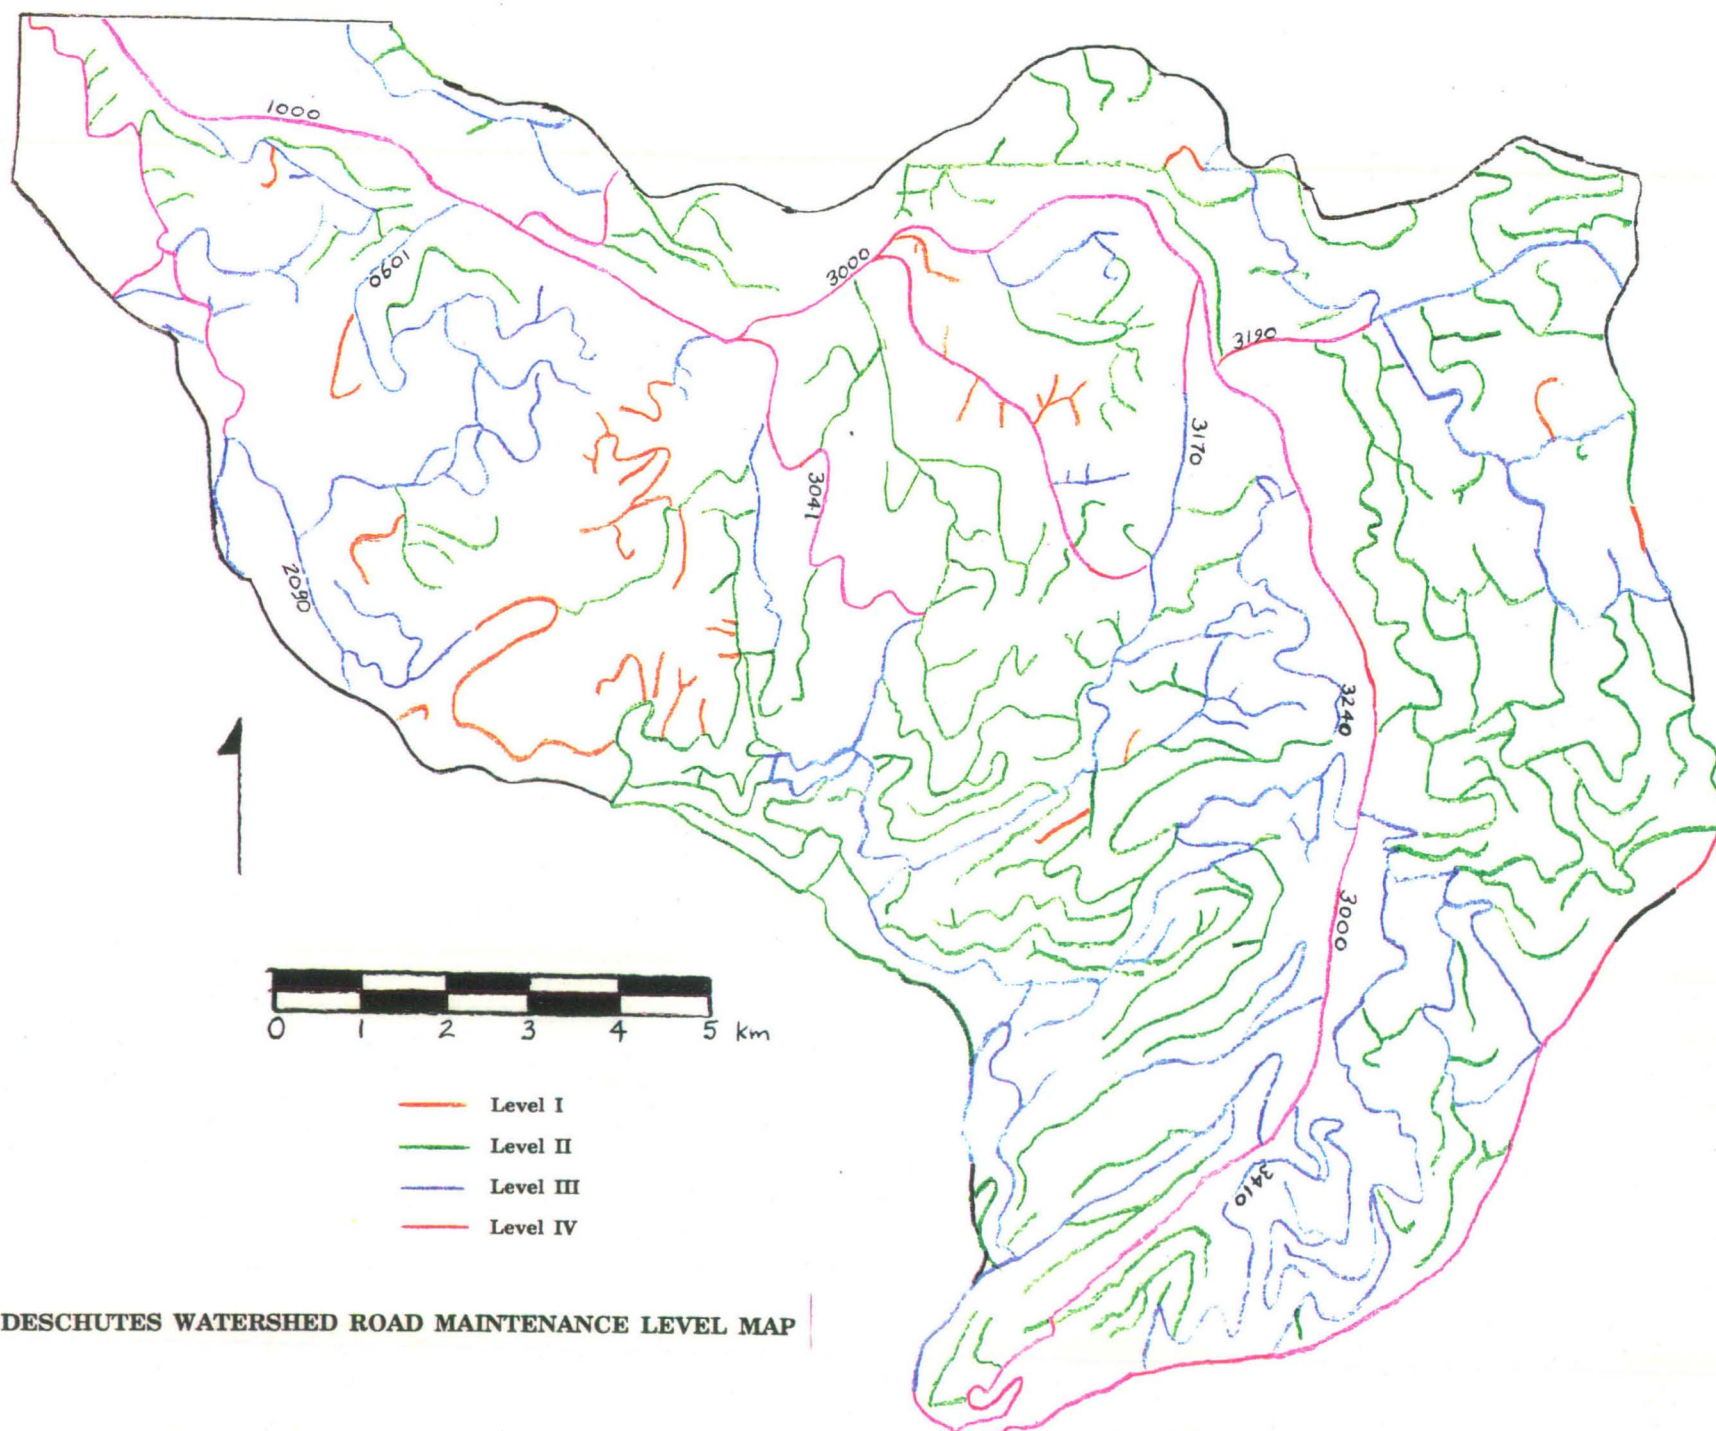
Figure 10. Upper Deschutes Basin Road Maintenance Level Map

Examining the information from the maintenance level map and the road damage form showed significantly different damage rates for each maintenance category (see figure 12). Level 1 roads averaged .031 damage sites/km, while level 2 roads averaged .308 damage sites/km. The damage rate for level 3 roads declined to .110 damage sites/km and for level 4 roads declined further to .058 damage sites/km.
